# Gutter Clearance Report

| Project | 9 Willow Way: gutter clearance (completed example) |
| Date | 12 Oct 2026 |
| Operative | K. Lane, Clear Gutters |

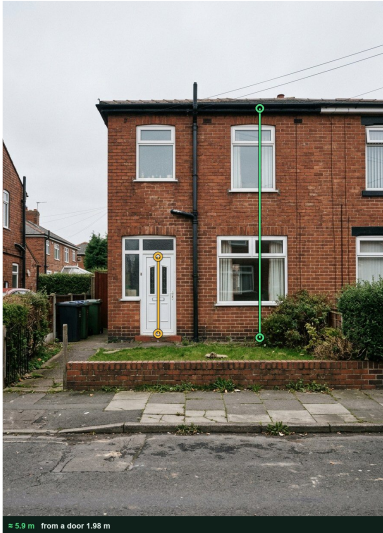
## Height to the gutter (m): measuring photo

| Height to the gutter (m) | 5.90 |

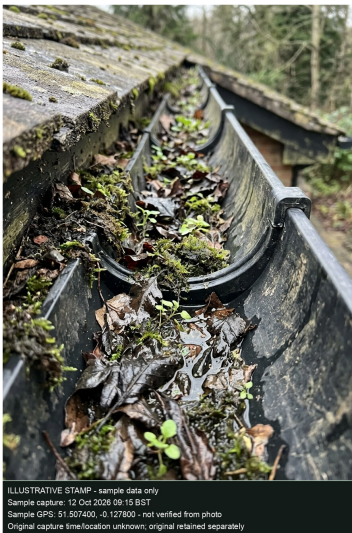
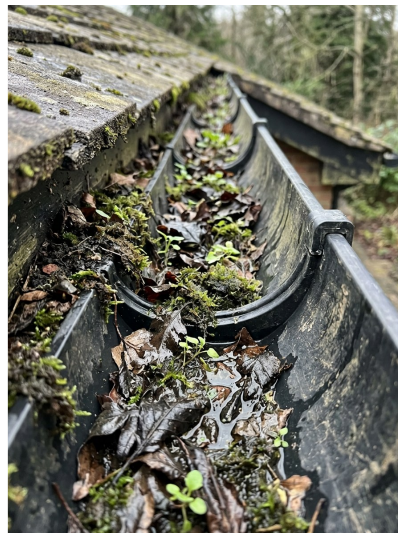
## Before photos

Partly blocked

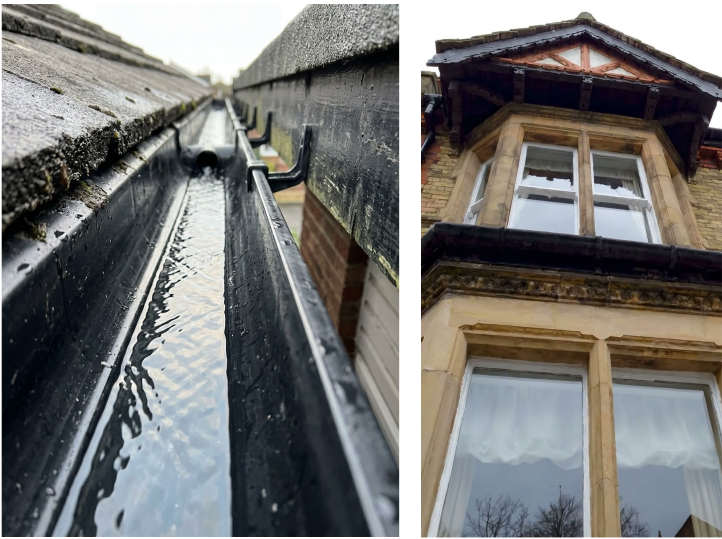
After photos

Downpipes flushed and running? Yes

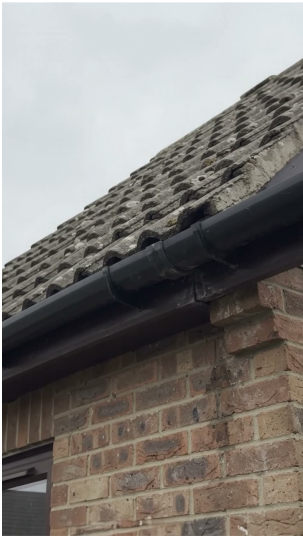
Before photos

| Blockage | Fully blocked |

Damage found on this run Joint above the back door leaking.

| Recommendations and quote | Replace the rear joint union: £45 including parts. Garage downpipe gully to be rodded: £60, or by your drainage contractor. |

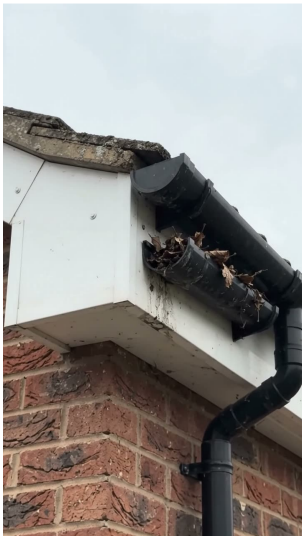
**Before photos**

| Blockage | Partly blocked |

| Damage found on this run | Garage downpipe still slow after flushing: blockage below ground at the gully. |
