SITE SURVEY REPORT

# HVAC and Air Conditioning Maintenance

| Project | Calder House, Wakefield: air conditioning service (completed example) |
| Job or work order reference | WO-58213 |

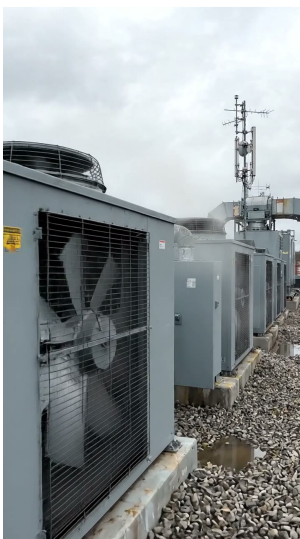
#### Photos before the work

Filters Checked, no action needed

| Coils | Cleaned on this visit |
| Condensate drain and pump | Not applicable |
| Fans and belts | Satisfactory |
| Electrical connections and controls | Connections tightened |

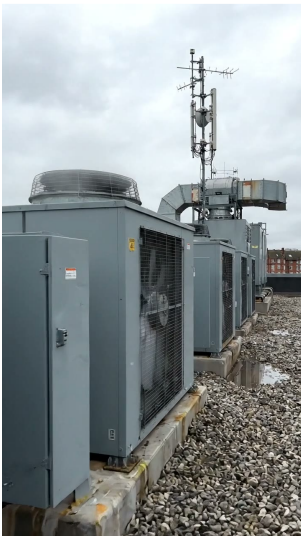
Photos after the work

| Any defects on this unit? | No |
| How was the unit left? | Running normally |

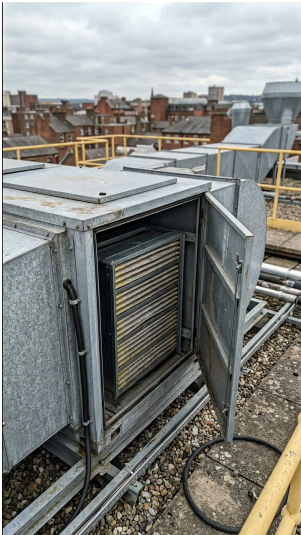
Photos before the work

| Filters | Replaced |
| Coils | Clean |
| Condensate drain and pump | Cleared on this visit |
| Fans and belts | Adjusted |
| Electrical connections and controls | Satisfactory |
