# Insurance Claim Inspection

| Project | 7 Riverside Cottages: river flood claim inspection (completed example) |
| Claim number | HI-778120 |

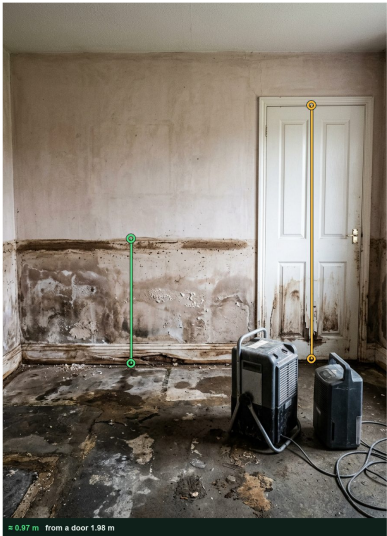
| Height of the water or tide mark above the floor (m): measuring photo | |

| Damage | Tide mark across all walls. Plaster wet below it, skirting swollen, carpet and underlay removed. Measured along the wall with the door in it. |
| Height of the water or tide mark above the floor (m) | 0.97 |

| Next steps (drying, contractors, specialist reports) | Drying readings weekly; drying certificate expected late October, then strip out the wet plaster to about 1.2 m and refit the kitchen. |

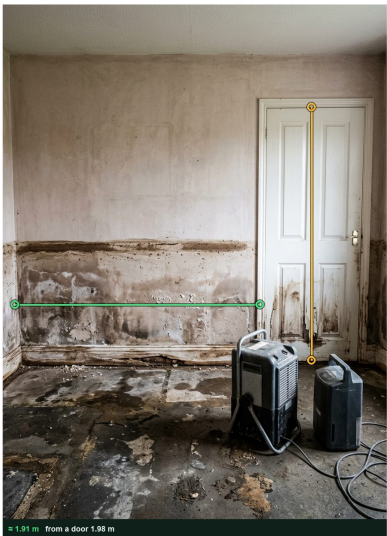
| Width of the damage (m): measuring photo | |

| Width of the damage (m) | 1.91 |

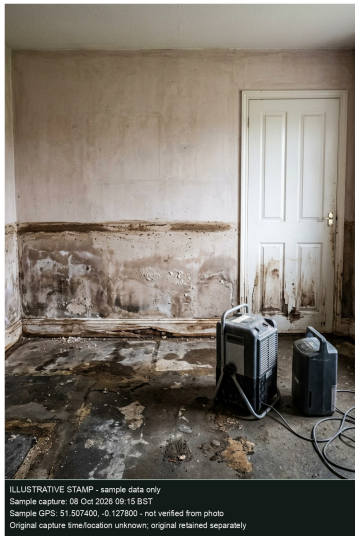
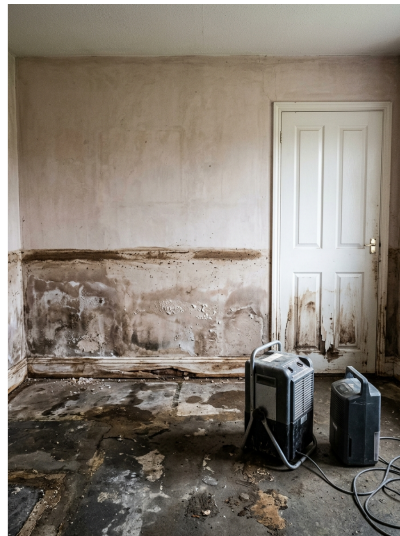
Illustrative stamp: 8 Oct 2026  
09:15 BST · sample GPS 51.5074,  
-0.1278. Original photo capture  
date/location unverified.

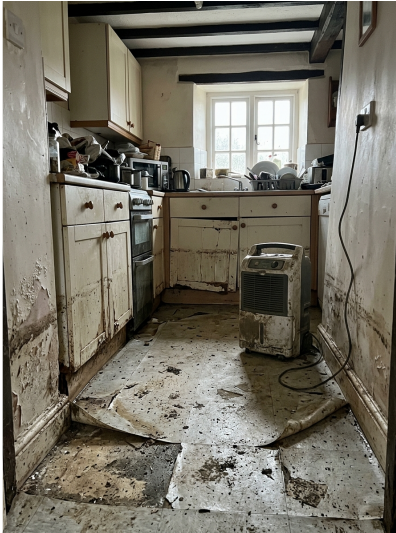
| Damage | Base units swollen and delaminated, vinyl lifted, plaster wet to the tide mark. |
| Height of the water or tide mark above the floor (m) | 0.95 |
