## SITE SURVEY REPORT

# Landlord Electrical Visual Check

| Project | 27 Oak Street: visual electrical check at change of tenancy (completed example) |

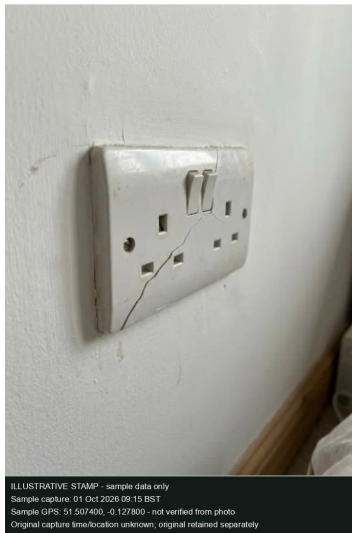
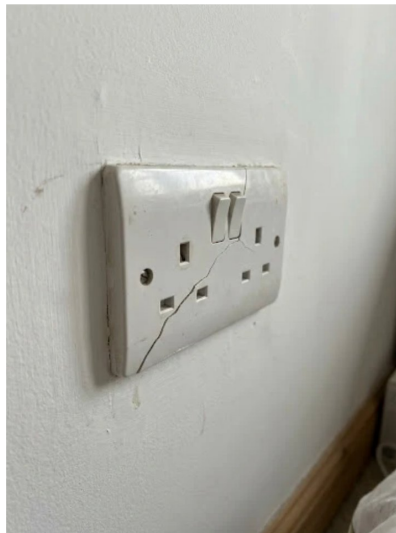
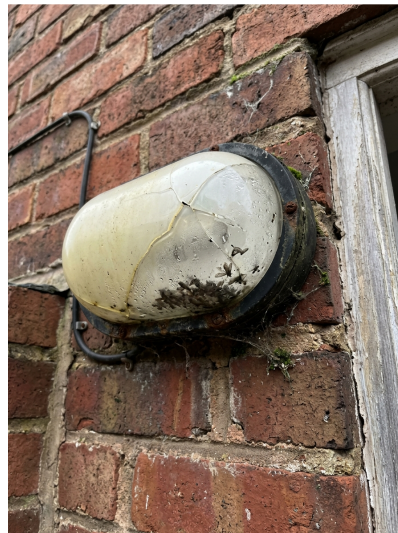
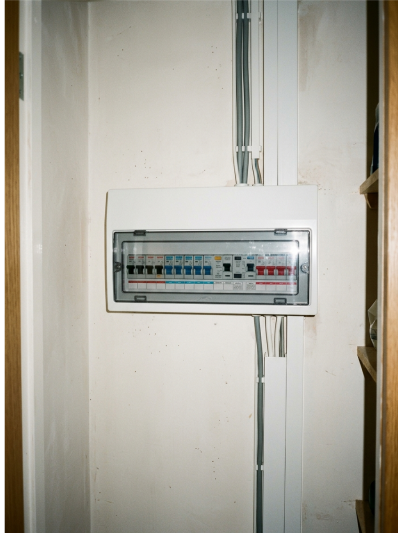
#### Photos of any problems

| What is wrong? | Cracked socket faceplate in bedroom 2. |

| What is wrong? | Back door bulkhead light: diffuser cracked and water inside the fitting. |

What needs doing? Electrician to replace the bedroom 2 socket before move-in.

What needs doing? Electrician to isolate and replace the back door bulkhead light before move-in.
