# MEWP Pre-use Inspection

| Site | Wellington Square Shopping Centre, Hastings |

| Project | Wellington Square Shopping Centre, Hastings: atrium lighting |

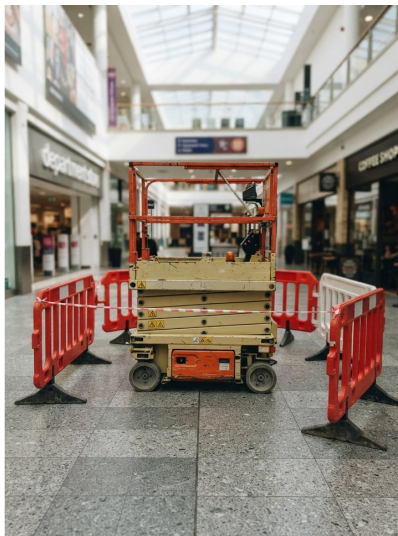
#### Supporting photos

| Action, limitation or reason not applicable | Tiled atrium floor checked for load on the centre drawings. Two floor box lids on the route. Route set to avoid them and barriers round the work area. |
