# Office Risk Assessment

| Date | 7 Oct 2026 |

| Project | Fenmoor Pike Accountants, Cambridge: office risk assessment (completed example) |

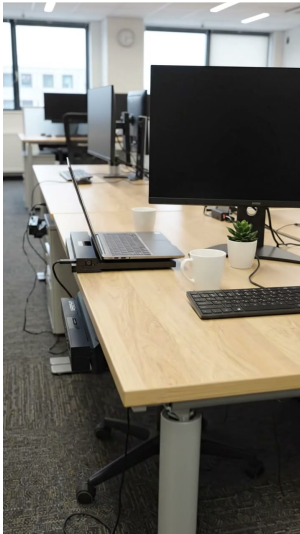
#### Area photos

| What is the hazard here? | Sixteen desks with two screens each; staff hot-desk on Fridays. |

| What is the hazard here? | Audit seniors work alone in the office until about 21:00 in January. |

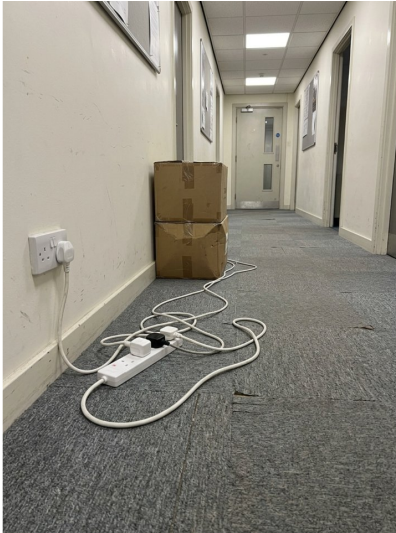
## Photos

| What needs doing, or why not checked | Extension lead run across the first floor corridor to the printer by the meeting room, with archive boxes beside it. |

| What is the hazard here? | Extension lead trailing across the corridor to the printer, with two archive boxes left beside it. |
| How could they be harmed? | Tripping over the lead or the boxes on the main route to the meeting room and fire exit. |
| What is already in place | None for this lead: it was put in when the printer moved in September. |
| Risk level now (your own scale) | Medium |

| Further action | Move the printer next to a wall socket in the print bay, remove the lead, and send the boxes to archive storage. |
| Status | Done, checked |
| Date done | 8 Oct 2026 |
