# Power Tool Inspection Checklist

| Prepared for | Irwell Quay Developments Ltd |
| Site | Hollins Yard, Salford |

| Project | Hollins Yard, Salford: power tool inspection (completed example) |

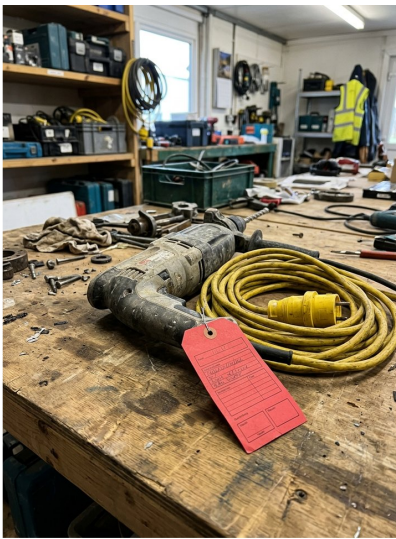
## Photos of the defect and the tag

| Bit, chisel or chuck secure, retainer or latch holds | Action needed |
| What needs doing, or why not checked | Chuck worn, bit slips out under load. |

| What was found | Red tag fitted. Booked in for a new chuck. |

**Actions 3: Replace the chuck on SDS drill T-103 and recheck before reissue.**

| Action | Replace the chuck on SDS drill T-103 and recheck before reissue. |
