# Pre-delivery Inspection

| Project | Van PDI: Mercedes-Benz Sprinter for Coast Plumbing (completed example) |
| Make and model | Mercedes-Benz Sprinter 315 L2H2 panel van |

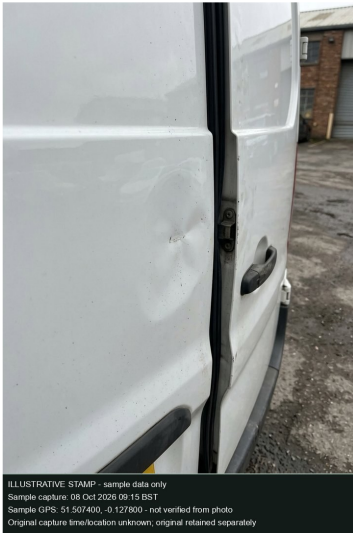
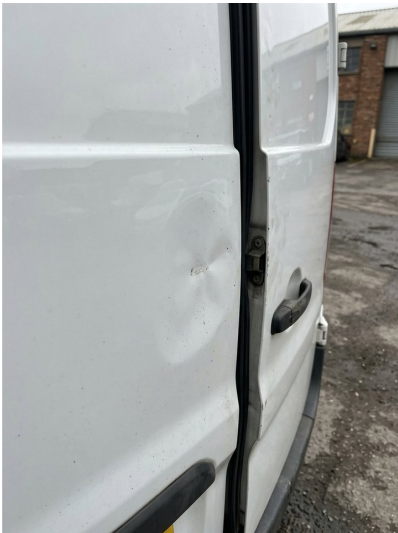
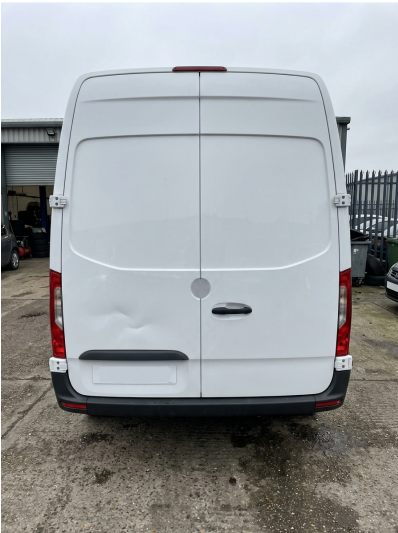
Photos of any defects

| Bodywork, paint and trim | Defect |
| What is wrong? | Shallow dent low on the nearside rear door from transport, about 280 mm across, paint unbroken. |

Defects agreed and when they will be fixed Smart repair to the nearside rear door dent booked for 15 October at our cost.

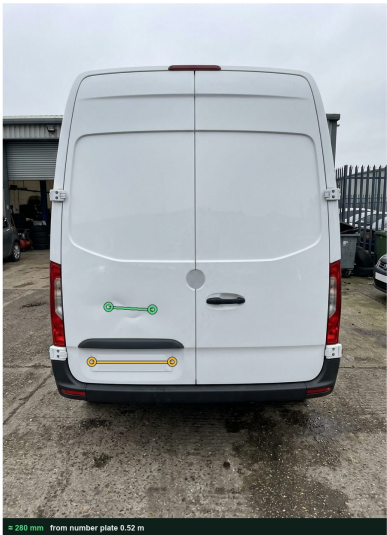
Largest defect length (mm): measuring photo

Largest defect length (mm)      280
