## SITE SURVEY REPORT

# Quick Issue or Defect

| Project | Larchfield Road play area: defect report (completed example) |

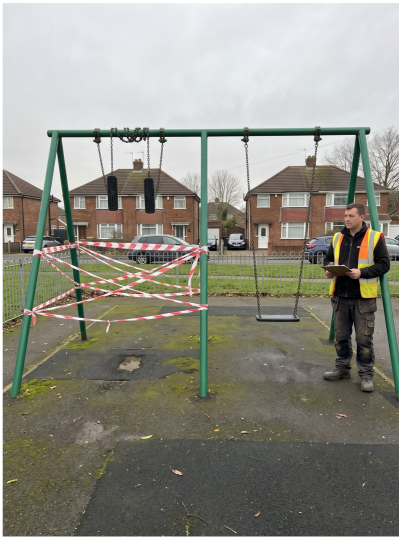
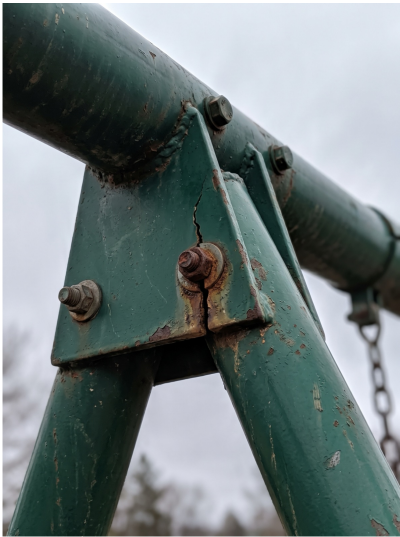
Photos

| What is wrong? | Top beam bracket on the left hand swing bay is cracked through one bolt hole and the beam has dropped slightly at that end. Found at the weekly routine inspection. |

How likely is it that someone is hurt or more damage is done? Possible

How bad would it be? Major

Risk score (1 to 9) 6

Priority Urgent

What was done to make it safe? Both seats on the left hand bay lifted over the top beam and the bay taped off with a sign. Right hand bay checked and left in use.

Status Fixed

Date fixed 14 Oct 2026

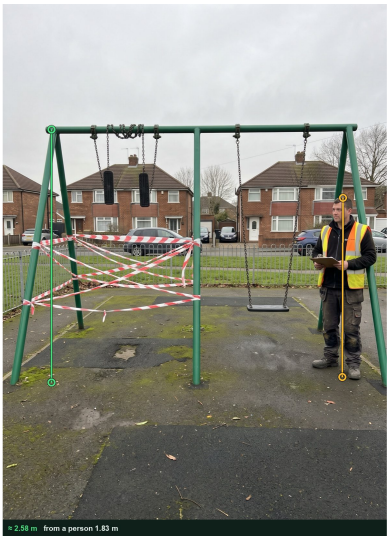
Height of the defect above ground (m): measuring photo

Height of the defect above ground (m) 2.58
