## SITE SURVEY REPORT

# Rack Audit

| Project | Bramley Court, Sheffield: comms cabinet audit |
| Cabinet ID | CAB-G01 |

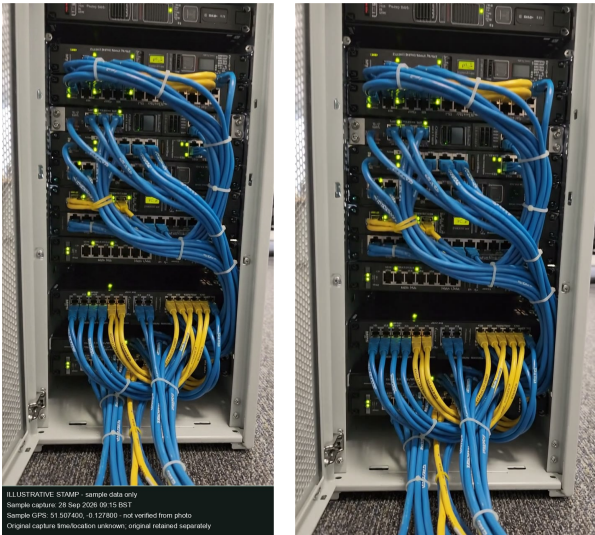
Photos of the front, doors open

| Cabinet lock | Lockable, found unlocked |

| Action needed | Lock the cabinet and give the key to the centre manager. Dress the power leads at the back onto cable bars, away from the data cables. Label the two unlabelled switches and their uplinks. Fit blanking plates in the empty U. Move one NAS power lead to PDU 2. Book a UPS battery test: 11 minutes of runtime is short of the 15 minutes needed. |

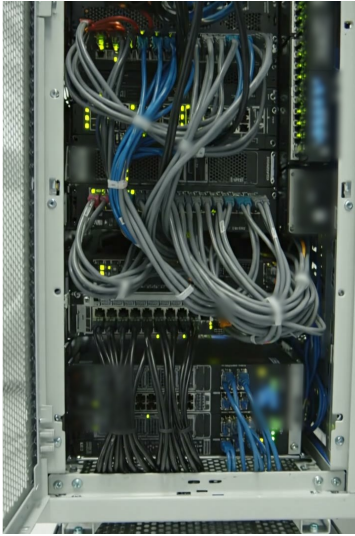
## Photos of the back

| Load notes | PDU 1 reads 9.8 A, PDU 2 reads 4.1 A. NAS has two power supplies, both plugged into PDU 1. Move one lead to PDU 2. UPS shows 11 minutes at 58% load; the centre wants 15 minutes to shut the NAS down cleanly. |
| Temperature at the back of the cabinet (°C) | 35.5 |
| Are empty U spaces fitted with blanking plates? | No |

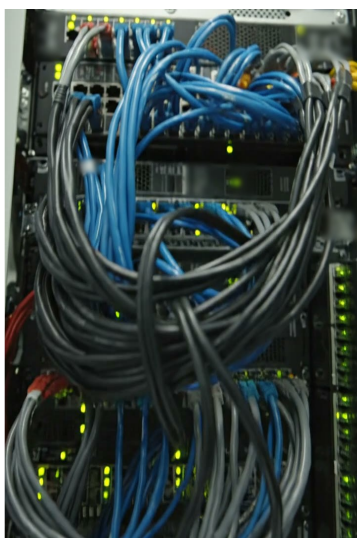
### Photos of the issues

| Is the patching tidy? | No |
| Does the labelling meet the site standard? | No |

| Issues found | Unlabelled cables, Loose or unsupported cables, Cables blocking airflow, Power and data not separated |
