# Rodent Bait Station Inspection Log

| Site | Greenfield Bakery |

| Project | Greenfield Bakery: monthly rodent monitoring (completed example) |
| Visit date | 9 Oct 2026 |

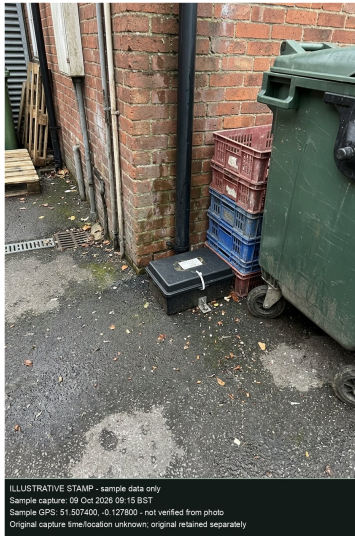
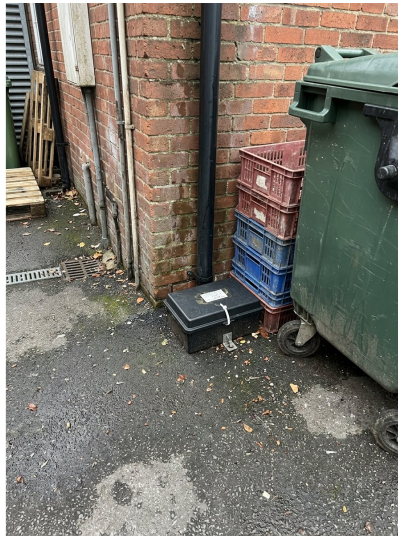
Stations in this area 1: EX01

| Position in this area | By the bins |
| Activity | Bait taken |

| Bait or block replaced? | Yes |
| Station condition | OK |

| Recommendations | Activity at EX01 and IN05: start a rodenticide treatment at the yard bins and recheck within 7 days. Fit a brush strip to the despatch door and seal the pipe entry behind the dry store racking. Replace IN06. |

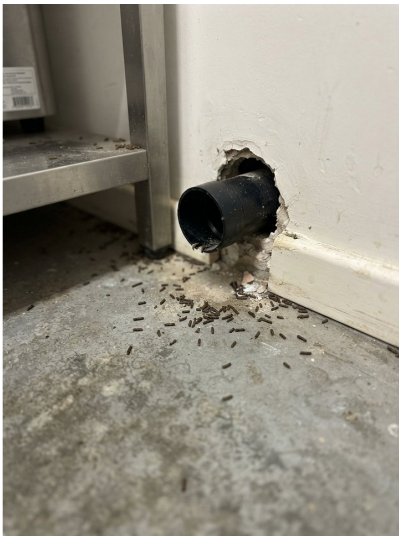
### Stations in this area 1: IN05

Position in this area Behind racking

Activity Droppings or gnawing

Station condition OK

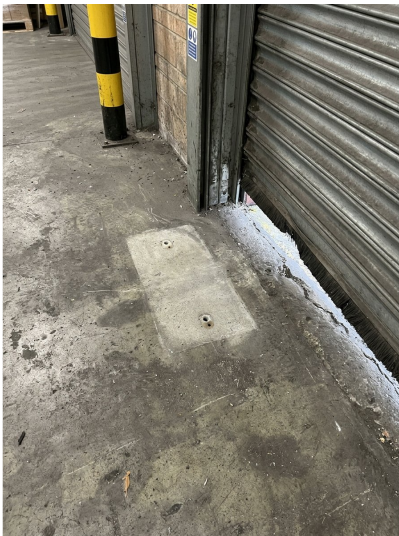
Stations in this area 1: IN06

| Position in this area | Despatch door |
| Station condition | Missing |
