## SITE SURVEY REPORT

# Roofing Installation Checklist

| Site | Cranmoor Primary School, Kettering |

| Project | Cranmoor Primary School, Kettering: roofing installation check (completed example) |

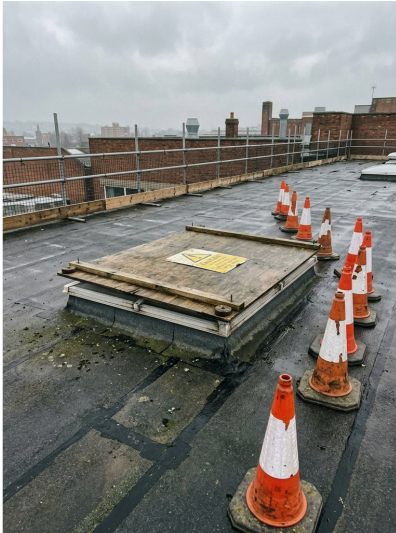
## Photos of the access and edge protection

| Edge protection in place for this inspection | Scaffold with guardrails and toeboards |
| Fall protection plan, method statement or RAMS reference | RAMS IVR-26-114 rev 1: scaffold edge protection and rooflight covers |
| Fragile surfaces (roof lights, sheets) identified and protected | Yes |
