# Septic Tank Inspection

| Project | Brook Farm Cottage: septic tank inspection (completed example) |
| Site address | Brook Farm Cottage, Clun, Shropshire |
| Inspection date | 10 Oct 2026 |

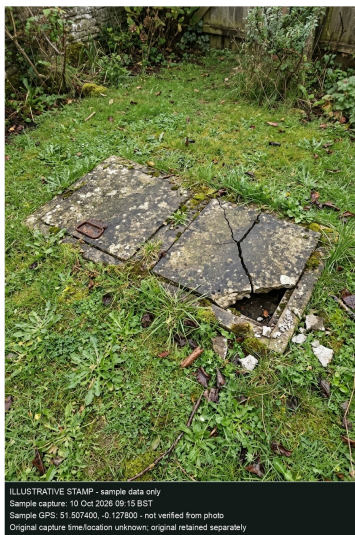
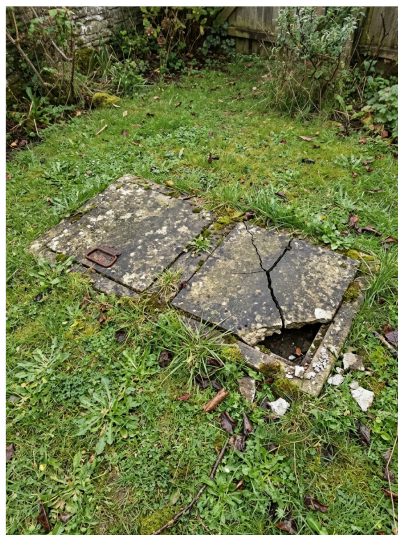
#### Photos of the tank

Lids and covers Damaged

Sludge level Near capacity

More than a year since the tank was desludged.

Tank defects Damaged inlet or outlet baffles

**Further actions 1: Desludge the tank (last emptied June 2025) using a registered waste carrier, and keep the waste transfer note.**

**Further actions 2: Replace the cracked inspection lid and the damaged outlet baffle.**

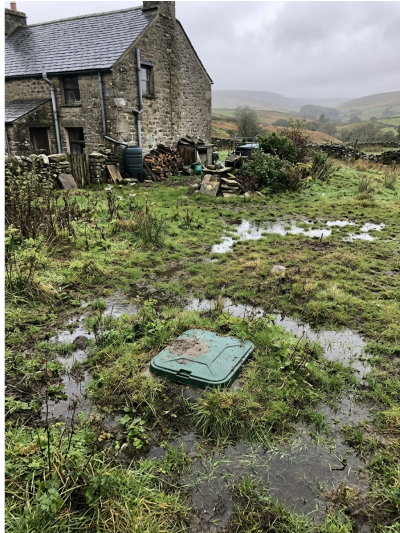
## Photos of the drainage field or outlet

Signs at the drainage field or outlet Pools of water

Further actions 3: Re-check the drainage field for standing water two weeks after desludging and after the next dry spell.
