# Stock Condition Survey

| Project | 12 Wensley Grove, Bramley, Leeds: stock condition survey |
| Survey reference | SCS-2026-1187 |
| Construction | Two storey semi detached, brick cavity walls, concrete tiled pitched roof |

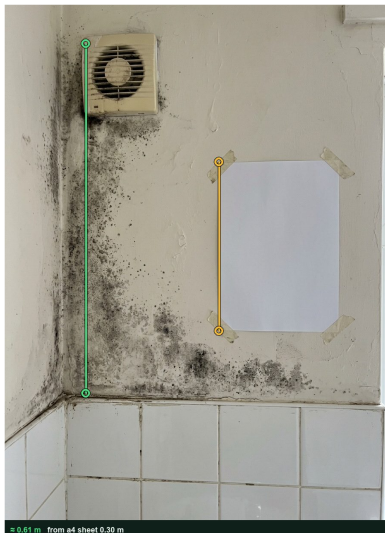
## Height of the mould (m): measuring photo

## Height of the mould (m)

0.61

Area of mould (m<sup>2</sup>)

0.26

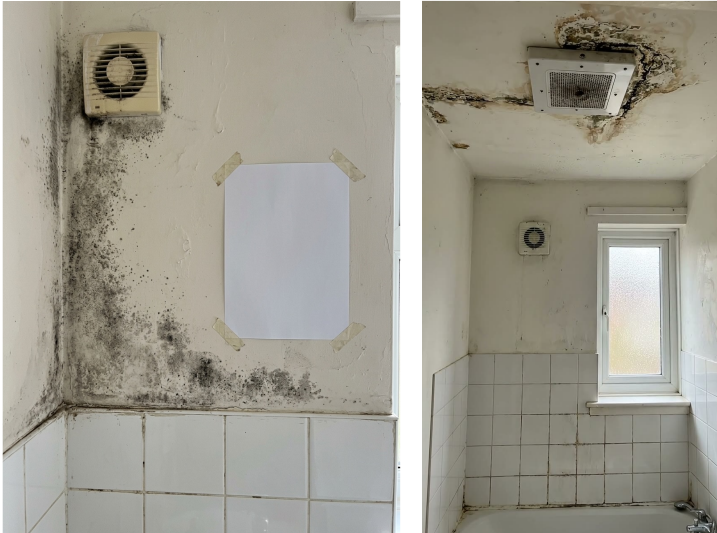
## Photos of the hazard

**Hazards found 1: Failing grout and sealant at a bath**

| HHSRS hazard | 11. Damp and mould growth |
| Room and location | Bathroom, ceiling around the extractor fan |
| What did you find? | Mould across the ceiling around the fan. Fan runs but is weak. Grout failing on the bath splashback. |

Damp and mould is reported to the repairs team on the day, not left for the survey to be processed.

Reported to the repairs team? Yes, on the day

Repair reference R-552190

| <b>What urgent work, and who was told?</b> | Refix the stair handrail (R-552191) and investigate the bathroom mould and weak extractor fan (R-552190). Both raised with the repairs team on the day, resident told. |

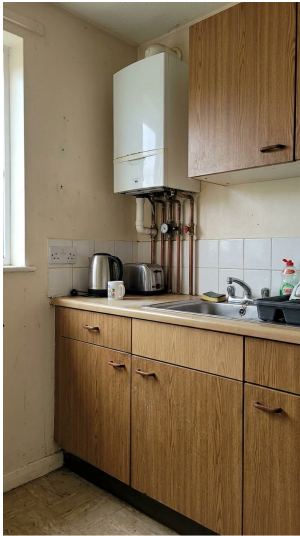
## Photos of the element

#### Elements surveyed 1: Kitchen

| Condition | Fair |
| Your estimate of remaining life (years) | 3 |

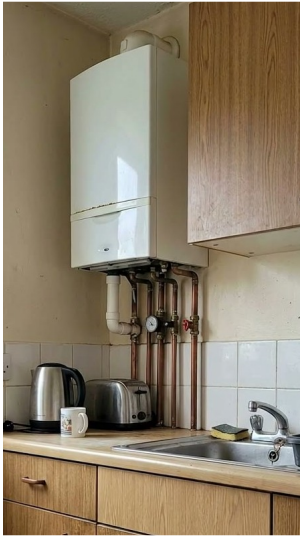
Photos of the element

## Elements surveyed 2: Gas boiler

| Condition | Fair |
| Your estimate of remaining life (years) | 2 |

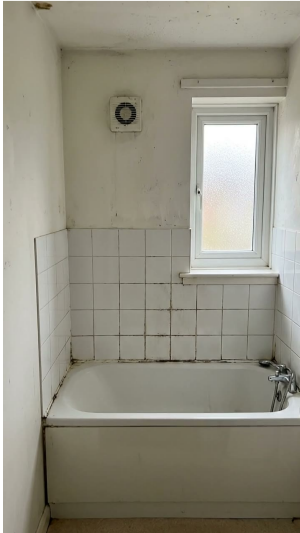
## Photos of the element

Elements surveyed 3: Bathroom

| Condition | Fair |
| Your estimate of remaining life (years) | 8 |

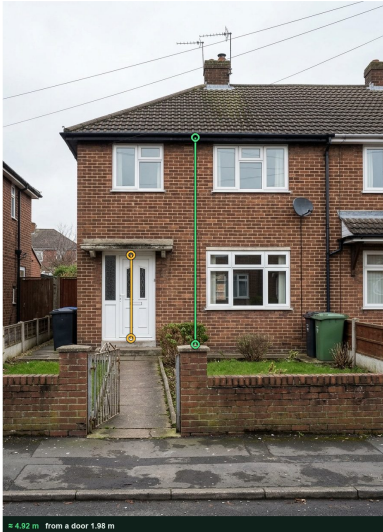
Length or height measured from a photo (m): measuring photo

| Length or height measured from a photo (m) | 4.92 |

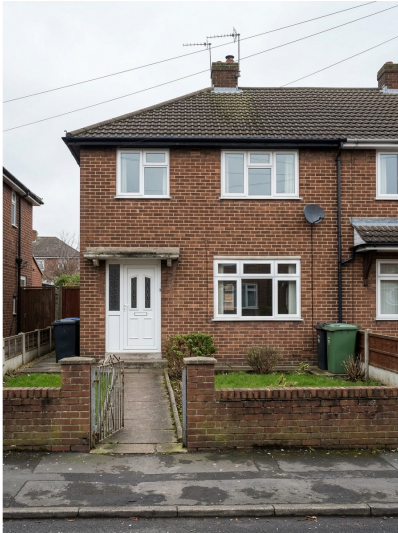
## Photos of the element

## Elements surveyed 6: External walls

| Condition | Fair |
| Your estimate of remaining life (years) | 20 |
