# Telehandler Daily Check

| Project | Kingsway Quarter, Gloucester: telehandler daily pre-use check (completed example) |

| Telehandler ID, model and location | Fleet TH-07, 14 m telehandler, plot C compound |

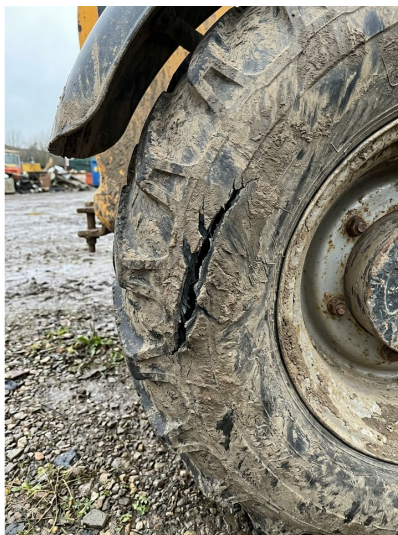
### Condition and defect evidence

| Tyres, wheels and visible chassis checked | Action needed |
| Action, limitation or reason not applicable | Cut in the sidewall of the rear left tyre, about 40 mm long. Reported before use and fitter called. |

| Restrictions, isolation and person informed | Keys removed and defect tag fitted to the steering wheel. Site manager R. Pattison and the hire desk informed at 07:50. |

**Further action 1: Fitter to inspect the rear left tyre and replace if needed. Job SVH-55120.**

| Completion evidence | Tyre replaced at 11:30. Recheck by B. Trevelyan, machine returned to use at 11:50. |
