## SITE SURVEY REPORT

# Vacant Property Inspection

| Project | 12 Bellhouse Street, Wakefield: weekly unoccupied inspection (completed example) |
| Inspection date | 14 Oct 2026 |

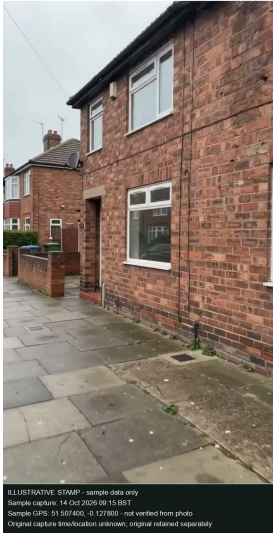
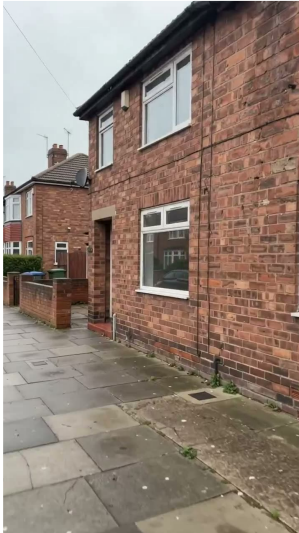
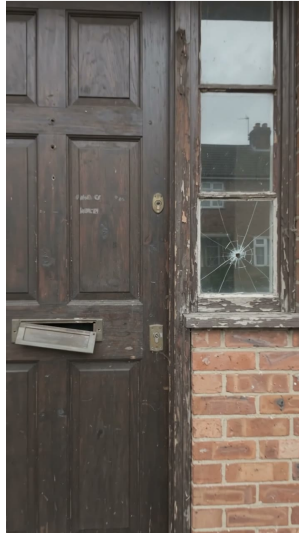
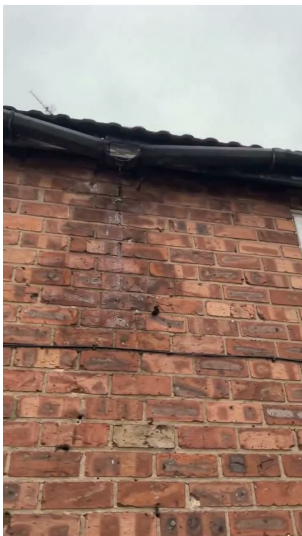
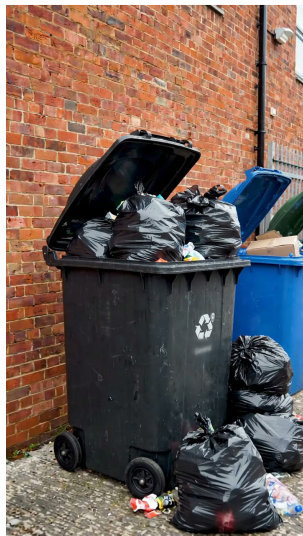
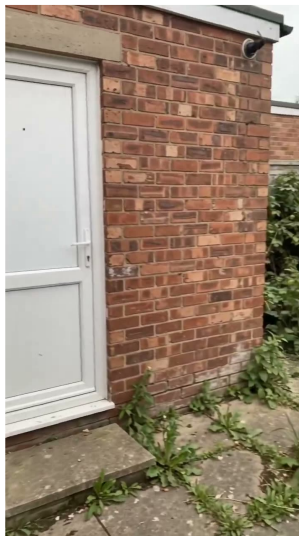
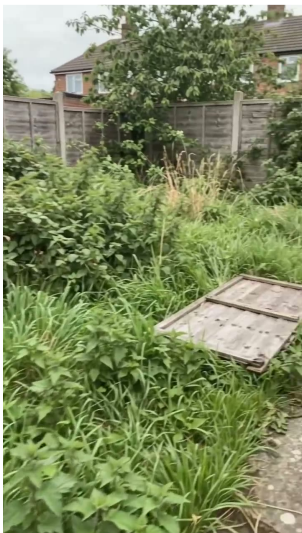
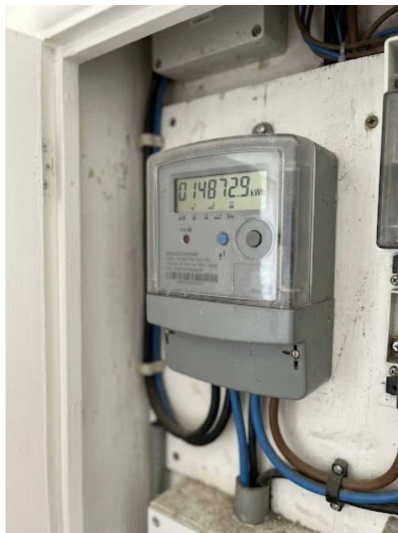
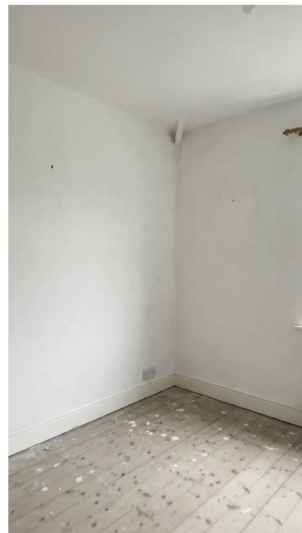
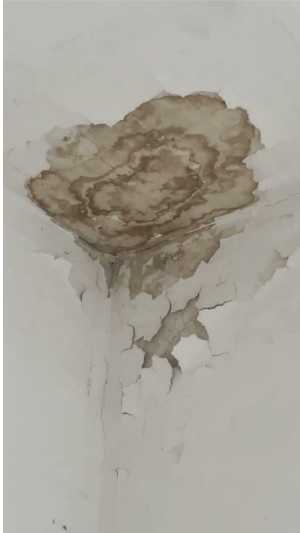
Photos (each room, meters, any issues)

| What is wrong? | Lower pane of the side light next to the front door cracked from an impact, glass still in the frame. Taped and boarded inside today. |

| What is wrong? | Five black sacks and loose bottles dumped beside the bins at the side passage since last week. |
| What is wrong? | Fence panel blown down at the back of the garden, rear garden now open from the next plot. Garden badly overgrown. |

| What is wrong? | Brown stain about 400 mm across in the ceiling corner of the first floor back office, plaster flaking below it. Not there on 7 October. Wall is outside under the eaves. |

| What needs doing? | Make the cracked side light safe: tape the pane and fix ply over it inside. |

| What needs doing? | Replace the cracked side light pane with a laminated unit. |

| What needs doing? | Clear the dumped sacks from the side passage and report the fly-tip to the council. |

| What needs doing? | Roofer to check the eaves, gutter and roof edge above the first floor back office for the source of the new ceiling stain. |

| What needs doing? | Re-fix the fallen rear fence panel so the garden is closed off again. |
