# Warranty Callback Visit Report

| Project | Quayside House, Bristol: callback for a ceiling leak (completed example) |
| Original job reference and date | AMS-2026-188: heating and cooling valves replaced on six fan coil units, second floor east |

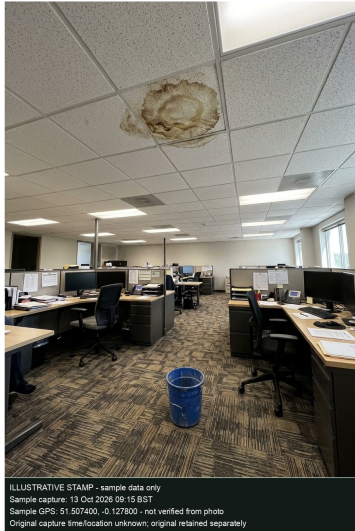
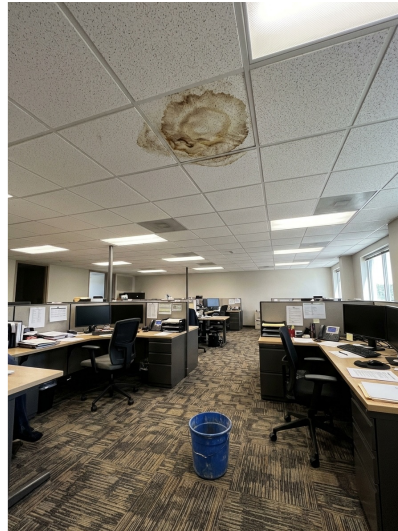
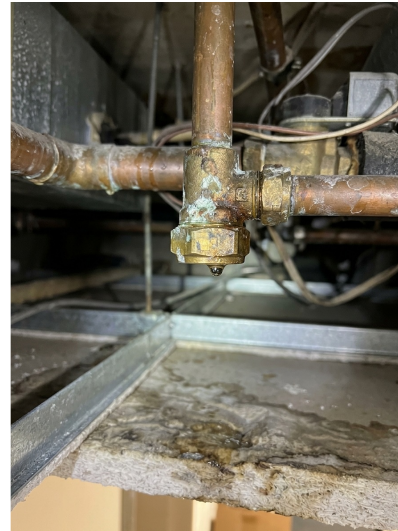
#### Photos (fault and fix)

| What was found | Compression nut on the heating return valve of FCU-2.06 weeping, about a drop every 20 seconds. Water had run along the pipe insulation to the tile. One ceiling tile stained; no damage to the unit or the floor. |
| Cause | Our workmanship |

| Work done | Isolated the heating circuit to FCU-2.06, remade the joint with a new olive, refilled and vented. Joint checked dry after 30 minutes at working pressure. Stained tile replaced from the client's spares. |
