## SITE SURVEY REPORT

# Asset Register Survey

| Site | Northgate Offices, Floor 3 |

**Asset register walk, Floor 3**

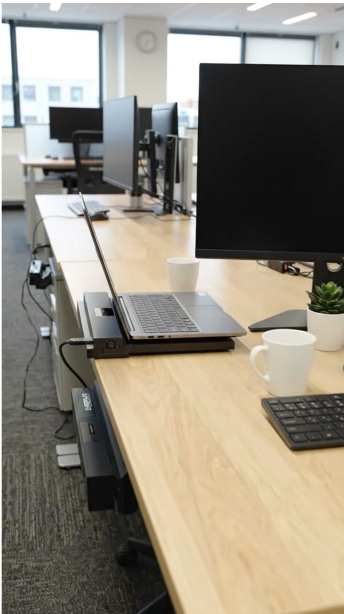
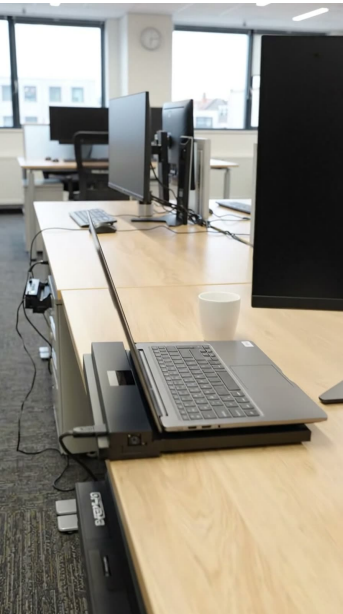
**1. Workstations**  
Floor 3 east. Twelve desks, monitors and docks, all tagged. Desks have light oak tops. Each desk has one monitor on an arm or stand and one dock at the desk edge. Two monitors due for replacement next year. Laptops are issued to staff and sit on the IT register, so they are not counted here.

| Desks, condition | Grade A. No damage to tops or frames |
| Monitors, condition | 10 at grade A. 2 at grade B (M004 and M009), uneven backlight along the lower edge |

| Action | Replace M004 and M009 in 2027. Priority 2 |

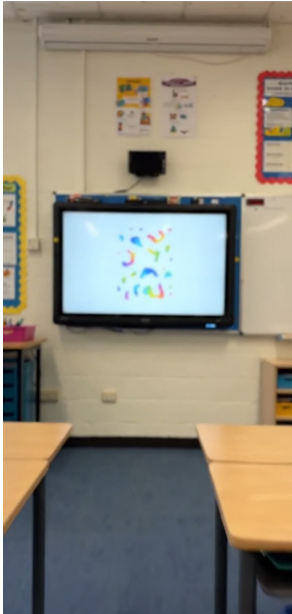
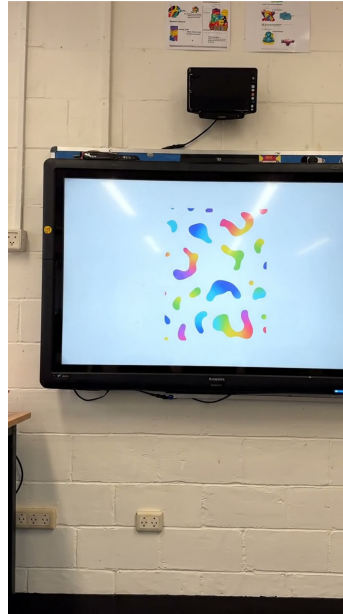
## 2. Displays

Room 12 interactive display. Installed 2021, condition good. Wall mounted on the end wall, powered on and showing a picture. Asset tag is on the left edge of the frame. There is a small wall unit above the display with its own power lead. No label can be read from floor level, so it is listed as not identified.

| Condition | Grade A. Powers on, picture clear, touch responds across the screen |

| Fixing | Wall bracket secure. Power and signal leads hang below the frame and are not clipped |
| Not identified | Small wall unit above the display. No label can be read from floor level. To be identified at the next visit with steps |

| Action 1 | Clip the power and signal leads to the wall below the display at the next visit. A short job. Priority 1 |
| Action 2 | Budget to replace the display around 2029, at the end of its expected life. Priority 3 |

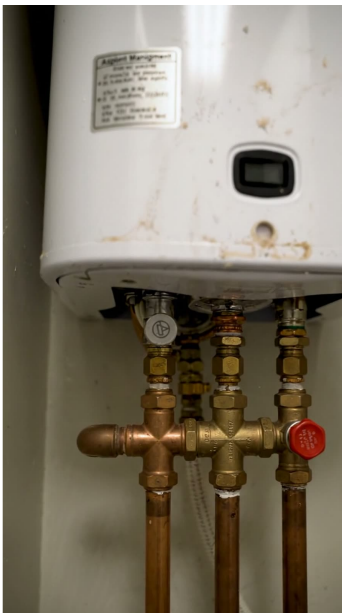
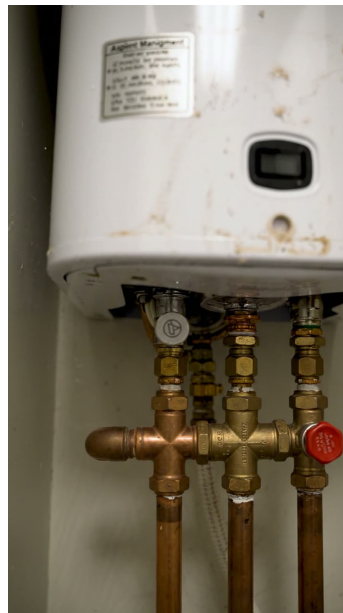
## 3. Plant

Water heater in cupboard B. Tag added, service due in March. Wall mounted unit with a label on the casing and a small display. Brown staining on the casing and around the lower edge. Pipework and valves below are dry today. Red handled valve on the right hand pipe.

| Condition | Grade B. Working, display lit. Brown staining on the casing and around the lower edge |
| Pipework and valves | Dry at the time of the survey. No drips seen on the fittings or on the cupboard floor |

| Action | Check the casing and fittings for a slow leak within the next few weeks, before the March 2027 service, then clean the casing. A possible leak is not left for the next service. Priority 1 |
