## SITE SURVEY REPORT

# Schedule of Dilapidations

| Site | Unit 4, Riverside Park |

| Property address | Unit 4, Riverside Park. Two storey business unit. This sample covers the first floor |

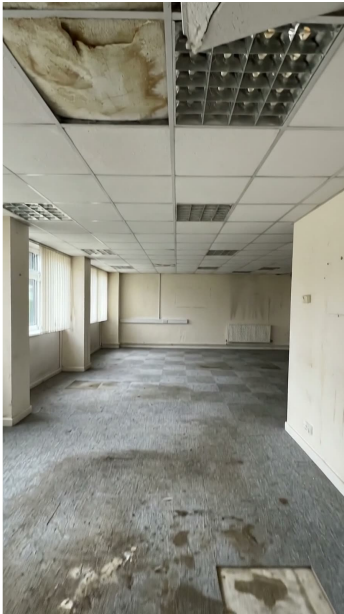
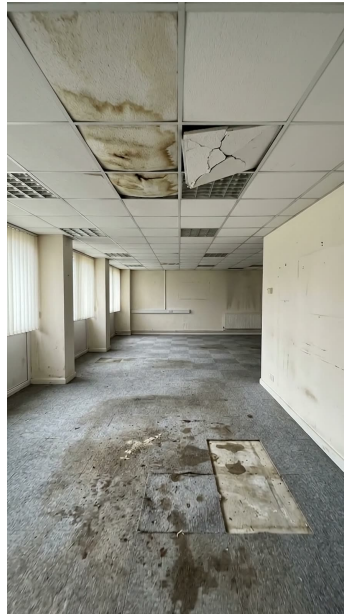
##### 1. Floors and ceilings

Office 2. Carpet tiles stained, some missing. Ceiling tiles water damaged, one broken. Staining is heaviest under the rooflight, check for a roof leak before replacing tiles.

| What needs opening up, and where? | Inspect the roof and the Office 2 rooflight from above, and the ceiling void around it, to find where the water staining in Office 2 comes from. To be done before the schedule is sent. See item 2 |

| <b>Item 1. Office 2, ceiling</b> | Poor. 1 ceiling tile broken. Remedy: replace 1 tile to match. 1 No at £35. Cost £35.00 |
| <b>Item 2. Office 2, ceiling and rooflight</b> | Fair. 3 ceiling tiles water stained, heaviest under the rooflight. The source has not been confirmed, as the roof and rooflight could not be inspected from above. Category: not a breach, until the source is confirmed by the further investigation in section 3. It will be added as a repair item only if the leak is confirmed and falls under clause 4.3. Not costed |
| <b>Item 3. Office 2, floor</b> | Poor. 6 carpet tiles missing. Remedy: supply and lay 6 matching carpet tiles. 6 No at £35. Cost £210.00. The carpet is also stained. Cleaning is not repair, so the staining is recorded but not claimed |

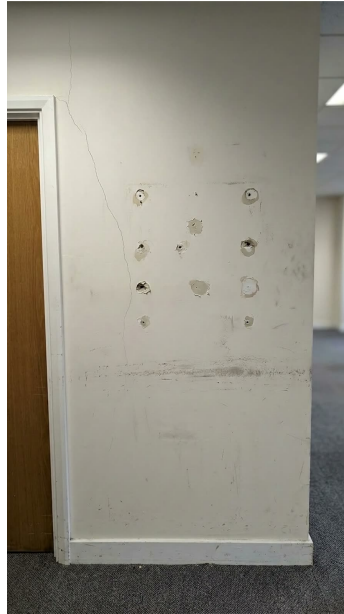
## 2. Walls

Office 1, wall beside the door. Screw holes and wall plugs from removed shelving, twelve in all. Needs filling and redecorating. Scuff line across the wall at desk height. Hairline crack running up from the head of the door frame, about 1.6 metres long.

| <b>Item 4. Office 1, wall by the door</b> | Fair. Hairline crack, about 1.6 m, from the head of the door frame. Remedy: rake out, fill and make good. 1 Item. Cost £120.00 |

| Item 8. Office 1, wall by the door (clause 4.8) | Reinstatement. Tenant's shelving removed, 12 screw holes and wall plugs left. Notice requiring reinstatement served 12 Jun 2026. Remedy: remove the plugs, fill and rub down. 1 Item. Cost £95.00 |
| Item 9. Offices 1 and 2, walls (clause 4.5) | Redecoration. Walls marked and scuffed, not redecorated in the last year of the term. Remedy: prepare and redecorate. 210 m <sup>2</sup> at £9. Cost £1,890.00 |

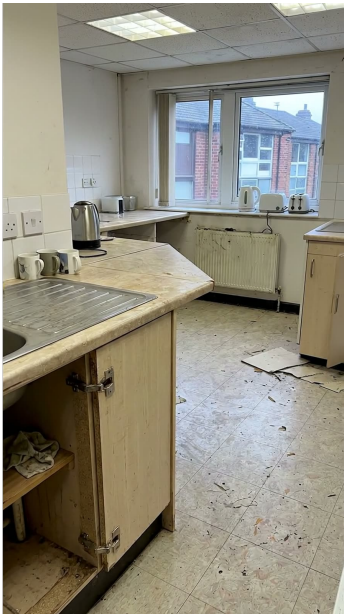
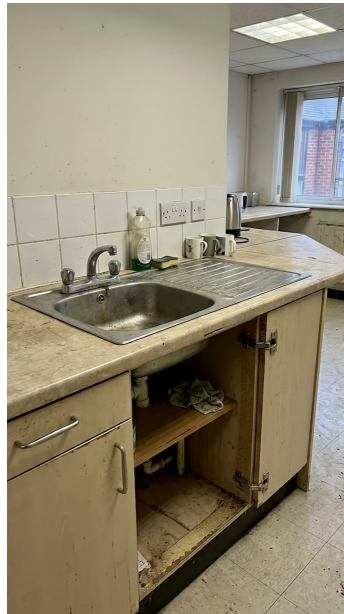
## 3. Kitchenette

Kitchenette. Worktop worn, sink unit chipped, cupboard doors missing, floor stained. Two doors missing from the sink base unit, hinges still on the carcass. Base of the unit is water stained. Floor tiles are lifting near the window. Kettles, toasters and mugs left behind.

| Item 5. Kitchenette, units | Poor. Worktop worn, sink base unit chipped with water damage to its base, 2 doors missing. Remedy: replace the worktop, base unit and doors. 1 Item. Cost £1,450.00 |
| Item 6. Kitchenette, floor | Poor. Vinyl floor tiles lifting near the window. Remedy: lift and replace the loose tiles. 3 m <sup>2</sup> at £45. Cost £135.00 |

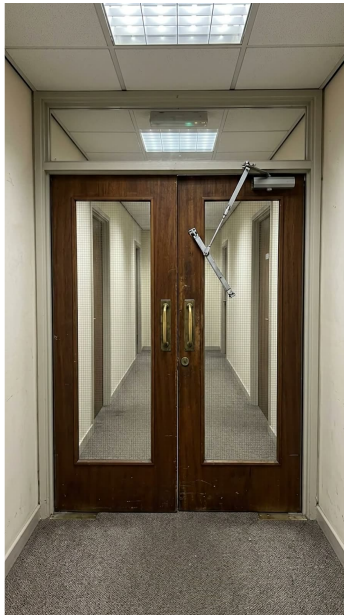
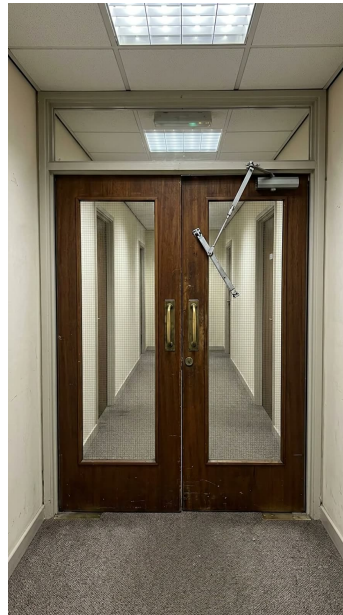
**4. Doors and fixtures**

Corridor fire doors intact. Check closers and seals against the lease schedule. Glazed panels are whole. Closer arm on the right hand leaf is hanging loose and the leaf does not close on its own. Scuffs to the bottom rails.

| Item 7. Corridor, doors | Poor. Closer arm loose on the right hand leaf, which does not close on its own. Remedy: refix and adjust the closer, check the seals. 1 Item. Cost £180.00 |
