## SITE SURVEY REPORT

# Fire Door Inspection

| Site | Elm Court, Block A |

| Report reference | FD-2026-0925 (sample) |

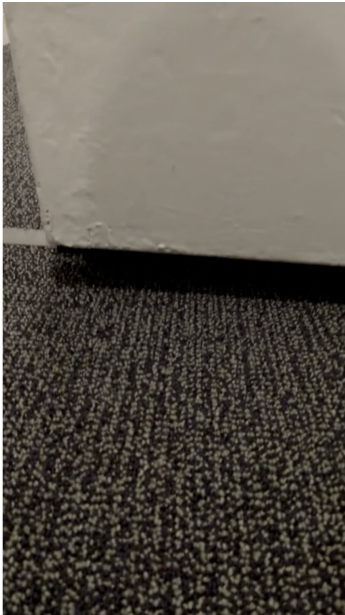
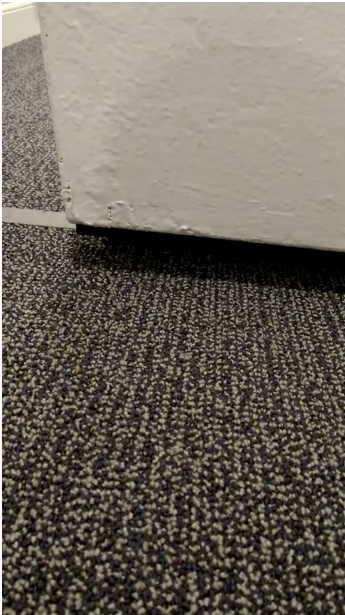
**1. Gaps**  
Flat 3 corridor door. Gap under the door about 12 millimetres, over tolerance. Door closes but does not latch every time. Seals along the top and both sides are intact. Door leaf has dropped slightly at the latch side.

**4. Door record: FD-03**

| Door, frame and wall | No damage that affects the fit. Leaf has dropped slightly at the latch side |
| Gap at the top and sides | Top 3 mm, hinge side 3 mm, latch side 3 mm |
| Gap under the door | 12 mm |
| Limit for this door in the door schedule | 8 mm (sample figure, taken from this door's own schedule) |
| Over the limit by | 4 mm |
| Self-closing test, from about 15 degrees | Closed to the frame but did not latch on 2 of 3 attempts |
| Result | Fail |

| Remedial action | Bring the gap under the door within 8 mm by adjusting the leaf, or replace the drop seal with one approved for this door set |
| Note on parts | Any replacement seal, threshold or packing must be approved for this door set. An unapproved part can take the door outside its tested specification |

| FD-03, gap and latching | Adjust the leaf, or replace the drop seal with one approved for this door set. Target Fri 9 Oct 2026 |

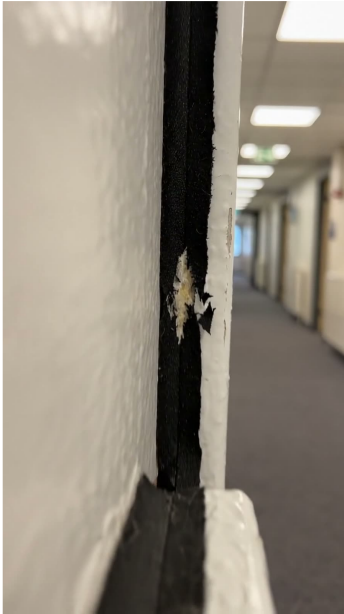
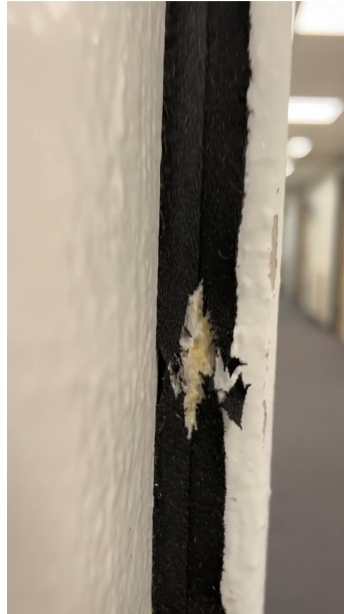
**2. Seals**

Level 2 corridor door, FD-09. Intumescent strip damaged on the hinge side. Replace. Torn through about halfway up, with the core showing. Paint on the frame edge is chipped beside it. Rest of the strip is in contact with the door edge.

**5. Door record: FD-09**

| Door, frame and wall | Paint chipped on the frame edge, hinge side. No split or hole |

| Intumescent strips and smoke seals | Damaged on the hinge side, torn through about halfway up. Sound elsewhere |
| Result | Fail |

| Remedial action | Replace the damaged strip on the hinge side with a strip approved for this door set |

| FD-09, seal | Replace the hinge side strip with one approved for this door set. Target Fri 9 Oct 2026 |

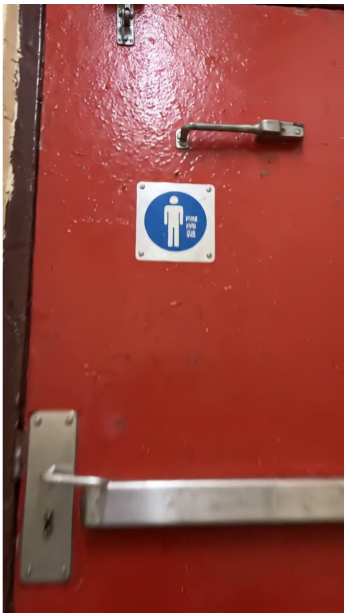
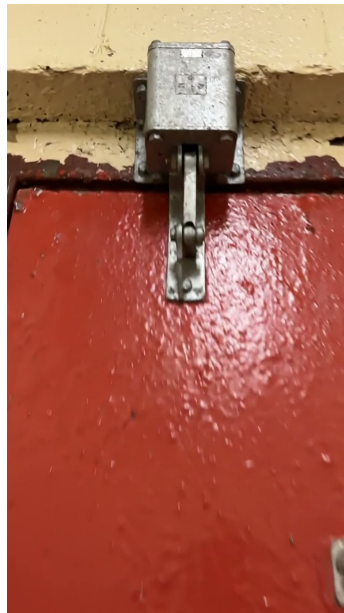
**3. Closer**

Ground floor rear lobby door, FD-21. Closer arm loose, door not latching. Fail, repair this week. Overhead closer is fixed to the wall above the door. Fixings at the arm bracket have worked loose. Push bar works.

**6. Door record: FD-21**

| Ironmongery | Push bar works. Closer arm bracket loose on the door |
| Self-closing test, from fully open | Did not close fully. Stopped short of the latch |
| Self-closing test, from about 15 degrees | Did not close fully |
| Result | Fail |

| Remedial action | Refix the closer arm, adjust the closer, test again from fully open and from about 15 degrees |

| FD-21, closer | Refix arm and adjust. Target Fri 2 Oct 2026. First priority, door does not close |

| Steps taken on the day | Caretaker told about FD-21. Door checked shut at the end of the round |
