# IT Site Survey

| Site | Unit 7, Example Business Park |

| Purpose of the survey | Survey before a quote. New data outlets and wireless access points for the open plan office |

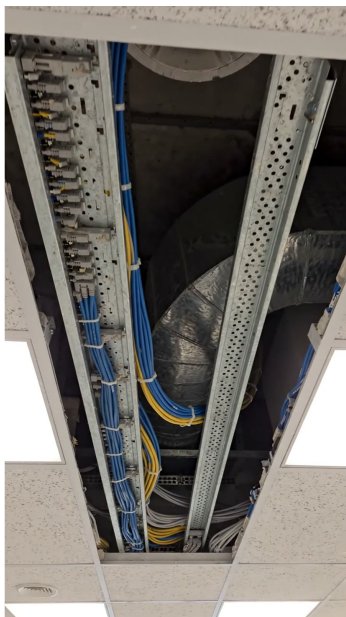
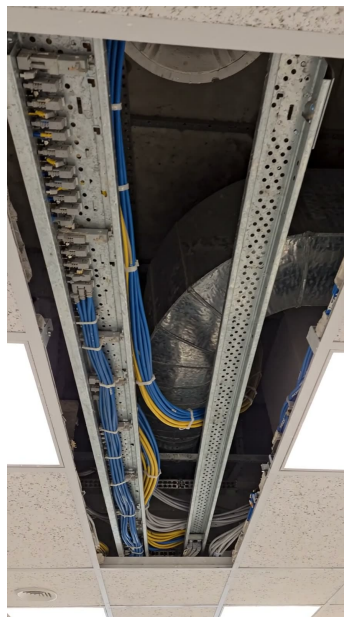
##### 1. Containment

Ceiling void clear, tray runs back to the comms room. Good route. Void depth around 400 mil. Two perforated trays side by side. The left one carries the existing blue and yellow cables, tied in bundles. The right one is empty. A flexible ventilation duct crosses above the trays here, so there is no room to work over the top of the tray at this point.

| Obstructions | Flexible ventilation duct crosses above the trays near grid line C. Cables to be laid in from below at that point |

| 6. Ventilation duct in the void | Allow for laying cables into the tray from below where the duct crosses |

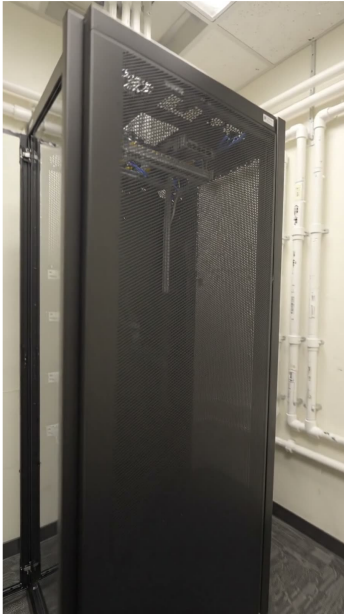
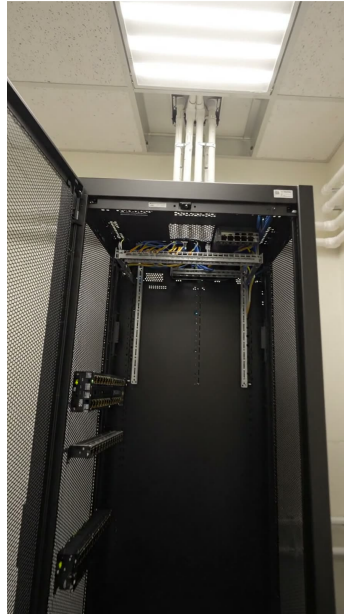
## 2. Comms room

42U cabinet, about 20U free. Power in, no cooling yet. Patch panels and a small switch at the top, cables come in through conduits from the ceiling. Two power strips on the left rail. The rest of the cabinet is empty. Pipework on the wall beside the cabinet, not labelled. No air conditioning and no extract in the room.

| Cooling | None. No air conditioning and no extract |
| Other services in the room | Pipework on the wall beside the cabinet. Contents not labelled |

| 1. No cooling in the comms room | Client to decide on cooling before the servers arrive. Total load is estimated at 1.2 kW |
| 2. Pipework beside the cabinet | Client to confirm what the pipes carry. Risk of water near equipment |

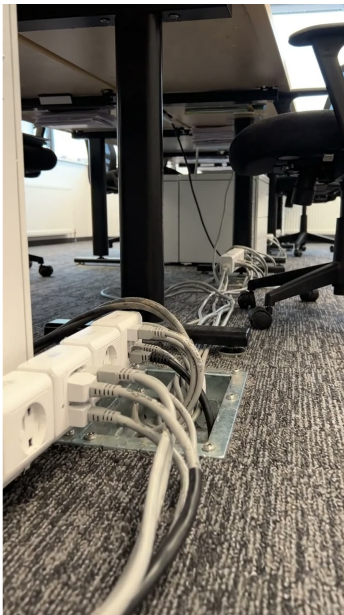
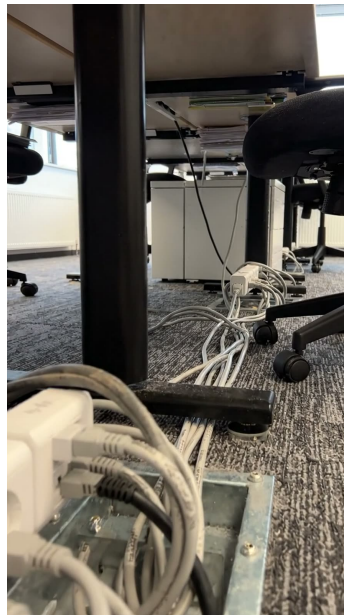
## 3. Outlets

Eight floor boxes on this run, two dead. Survey the rest of the floor. Lids are off and the patch leads trail across the carpet to the desks. Boxes three and six show no link on the tester. Leads are not labelled at the box.

| Floor boxes checked | 8. Working 6, dead 2 (boxes 3 and 6, no link on the tester). 75% working |
| Condition | Lids off on all eight boxes. Patch leads trail across the carpet |

| 4. Two dead floor boxes | Trace and test boxes 3 and 6 during the installation |
| 5. Rest of the floor | Return visit to survey floor boxes 9 to 20 and the riser cupboard |
