## SITE SURVEY REPORT

# Routine Property Inspection

| Site | 27 Mill Lane |

| Property address | 27 Mill Lane. Top floor, two bedroom flat in a two storey block |

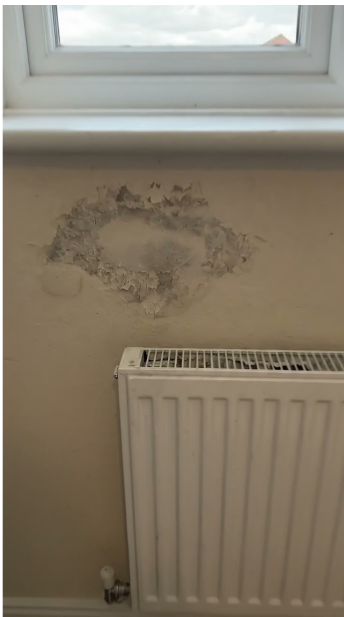
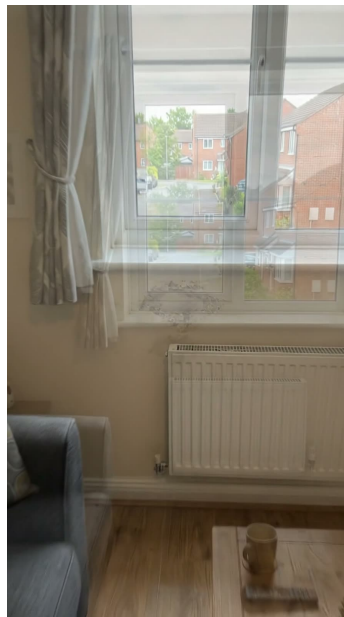
##### 1. Living room

Living room tidy. Damp patch on the wall under the window, above the radiator. Tenant says it appeared after the heavy rain last month. Paint has blistered and flaked, about 40 centimetres across. Radiator below is working.

| Living room | Good. Clean. Issue: damp or mould, reported by the tenant. Blistered and flaking paint with grey staining on the external wall below the window, above the radiator. Wall dry to the touch on the visit |
| Living room, patch | 0.4 m wide by 0.3 m high. Area 0.12 m <sup>2</sup> |
| Living room, likely source | Not yet known. Water may be getting in from outside, at the window cill or the gutter above |

| Living room, repair | Within 14 days. Landlord. Roofer to check the gutter, window cill and pointing outside, then make good the plaster and paint once dry |

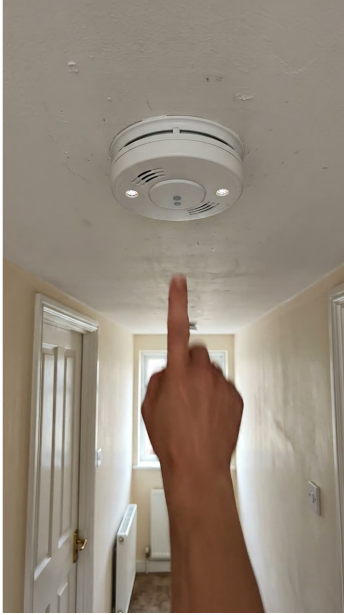
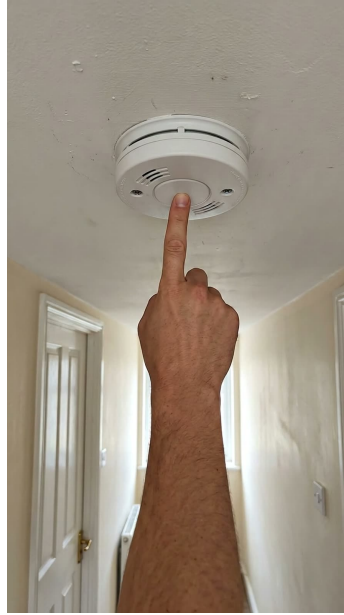
**2. Alarms**

Hallway smoke alarm tested and working. Ceiling mounted, test button pressed, sounder heard clearly.

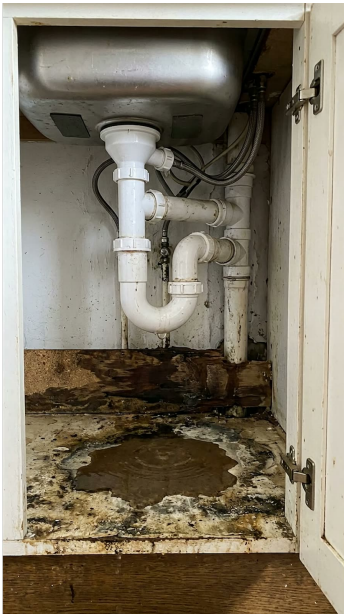
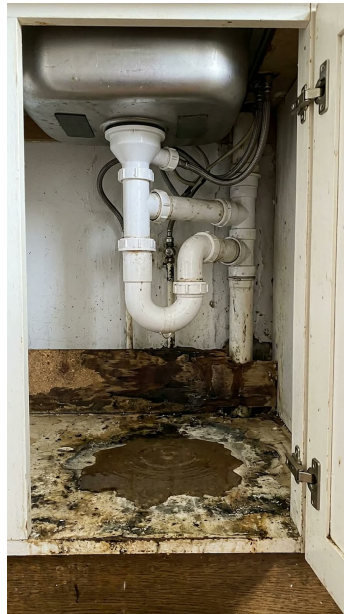
**3. Kitchen**

Slow leak on the sink trap, base of the cupboard is wet. Needs a plumber this week. Water is standing on the cupboard floor and the board is swollen and stained.

| Kitchen | Fair. Clean. Issue: leak, reported by the tenant. Slow drip from the joint at the bottom of the sink trap. Cupboard base wet, swollen and stained |
| Kitchen, is water still escaping? | Yes |

| Kitchen, repair | Within 7 days. Landlord. Plumber to reseal or replace the trap, then replace the cupboard base once dry |

| Anything done on the visit | Bowl placed under the sink trap. Tenant asked to empty it and to report any change |

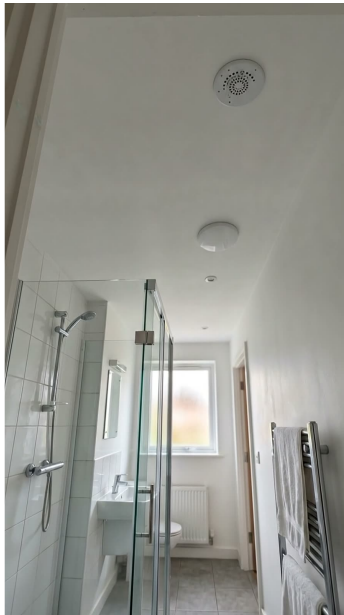
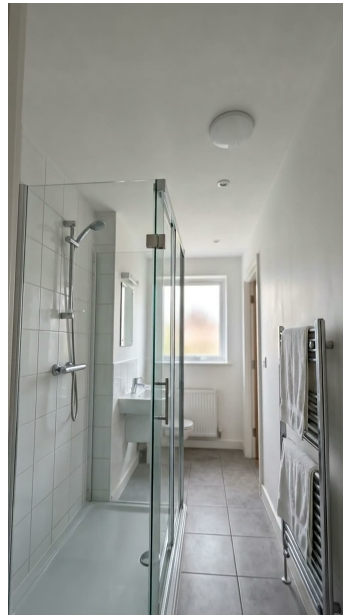
**4. Bathroom**

Bathroom clean and in good order. Shower screen and seals fine. Ceiling extractor running. No damp or mould seen.
