## SITE SURVEY REPORT

# Pre-installation Site Survey

| Site | Unit 7, Example Business Park |

| Purpose of the survey | Record the room before design and quotation for digital signage displays, ceiling loudspeakers and an equipment rack |

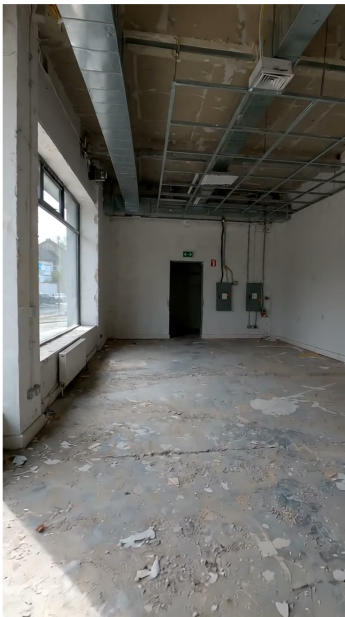
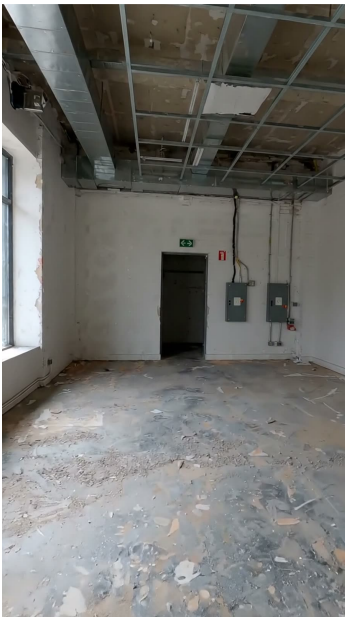
1. The space

Unit 7 shell. Open plan, shopfront glazing sound, floor level. About 180 square metres usable. Old ceiling grid is still up at this end with the tiles out. Rear door in the back wall with the exit sign over it, two distribution boards to the right of the door. Floor is bare screed with loose debris, needs a sweep before any access equipment comes in.

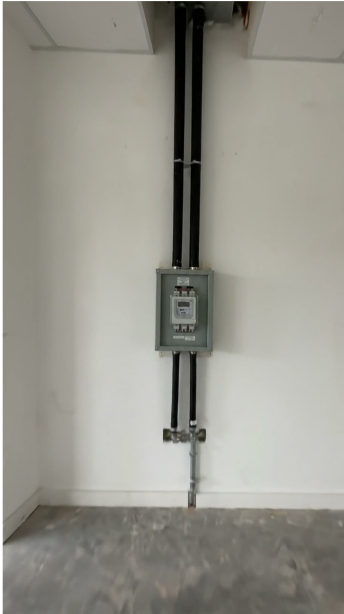
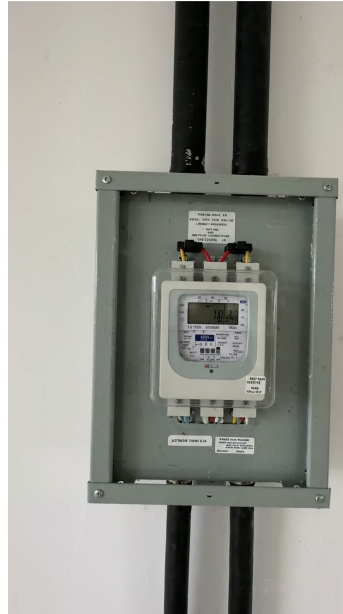
## 2. Power

Intake on the back wall. Supply looks adequate, confirm with the DNO. Meter is in a steel enclosure, two cables in at the top from the ceiling void and two out at the bottom. Labels on the enclosure photographed. Nothing opened and nothing switched on this visit.

| Intake and meter | On the back wall, in a steel enclosure. See Walk Cam point 2 |
| Supply capacity | Not confirmed. Client to confirm with the distribution network operator (DNO) |
| Spare ways for the new equipment | Not checked. Enclosures were not opened on this visit |

| 1. Supply | Client to confirm the supply capacity with the DNO. Needed before the electrical design. Owner: client. Needed by Fri 16 Oct 2026 |

| Revisit needed | Yes, once the electrical enclosures can be opened by the client's electrician |
