# Snagging Inspection

| Site | Plot 14, Riverside Mews |

| Report reference | SN-2026-0114 (sample) |
| Property | Plot 14, Riverside Mews. Two bedroom mid-terrace house, two storeys |

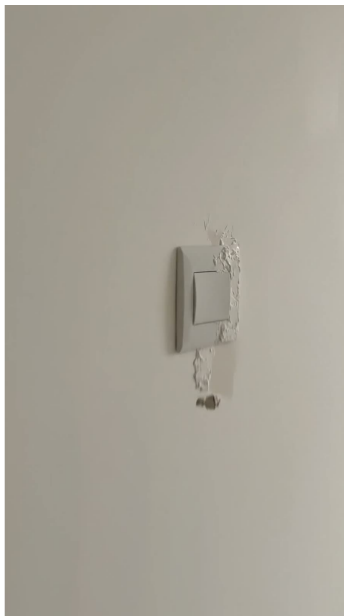
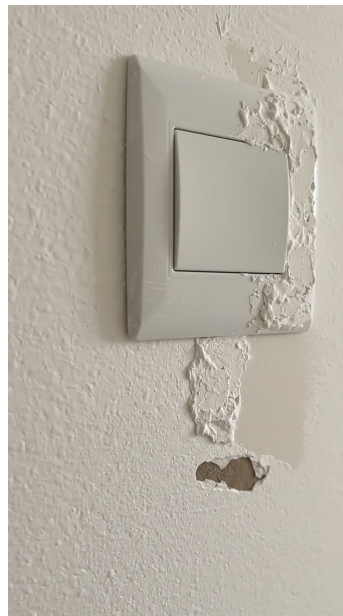
##### 1. Walls and finishes

Plot 14 living room. Paint patchy by the switch, chip in the plaster. Filler has been left rough down the right hand side of the light switch and over the edge of the switch plate. Below the switch there is a chip through the finish, about 30 millimetres wide, down to the backing. Decorator to make good before handover.

| S01 Living room, east wall | Rough filler beside the light switch and on the switch plate, patchy paint, chip in the plaster below. Decorator. Before handover. Open |

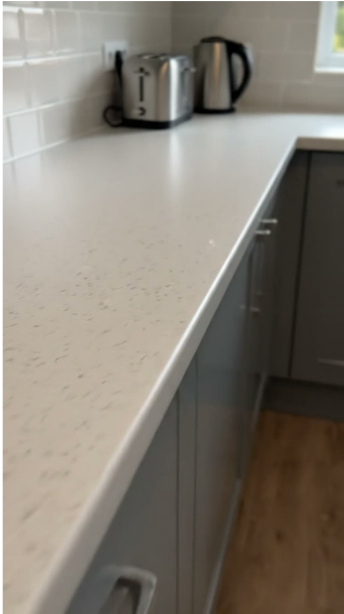
## 2. Kitchen

Kitchen. Unit door misaligned, not closing flush. It is the door beside the corner, under the worktop. The top edge sits out of line with the door next to it and the gap between the two is uneven. Worktop and the other doors checked, no damage. Kitchen fitter to adjust the hinges.

| S02 Kitchen, base unit by the corner | Door out of line with the next door, uneven gap, not closing flush. Kitchen fitter. Before handover. Open |

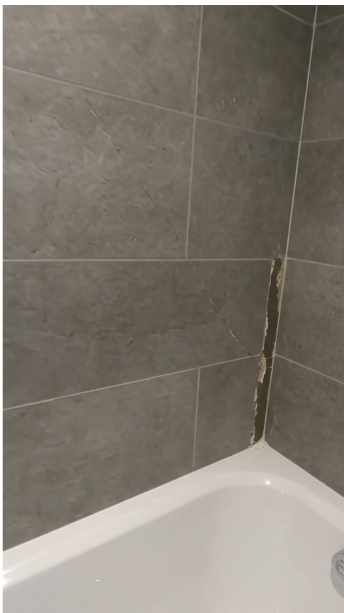
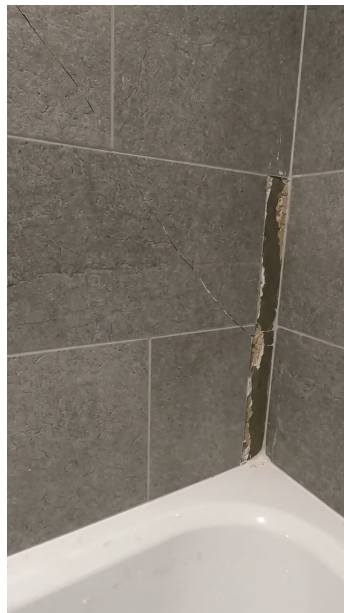
## 3. Bathroom

Bathroom. Cracked tile and missing grout by the bath. Crack runs diagonally across the wall tile above the bath, into the corner. Hairline crack in the tile above it as well. The joint in the corner is open from the bath edge up past two tiles, with the backing showing. Sealant along the bath edge is in place. Tiler, before handover.

| S03 Bathroom, wall above the bath | Cracked wall tile, hairline crack in the tile above, corner joint open for the height of two tiles. Tiler. Before handover. Open |
