# Basement and cellar inspection visual route

DEMO-BASEMENT-CONDITION-001

Illustrative Victorian cellar / four separate scenes

Illustrative check after heavy rain

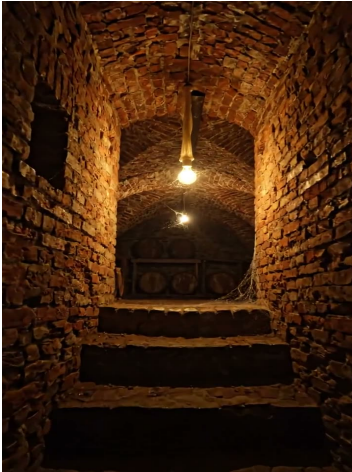
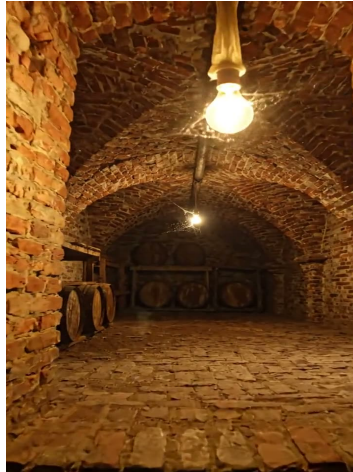
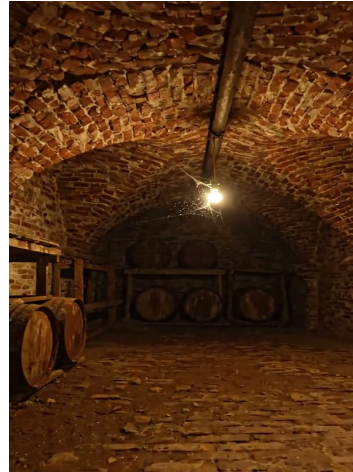
### 01 Access and lighting

Brick steps lead down into a lit cellar.

Note any area too dark or unsafe to enter.

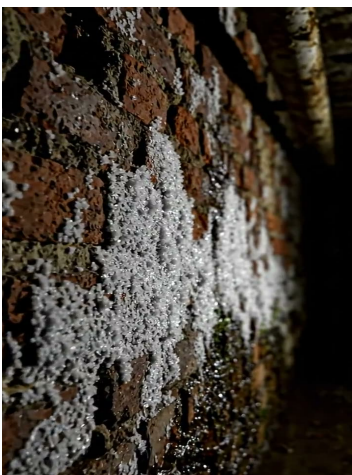
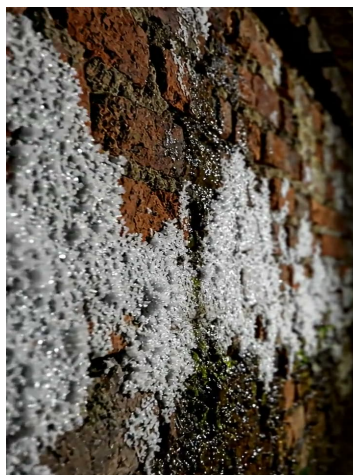
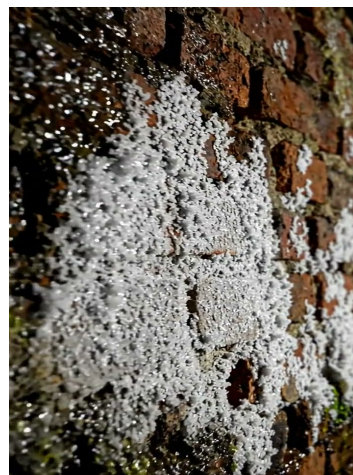
### 02 Walls and tide marks

White salt deposits and a tide mark show low on the cellar wall.

Record the height of the tide mark and check it after rain.

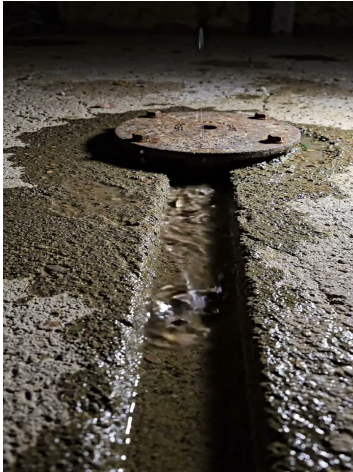
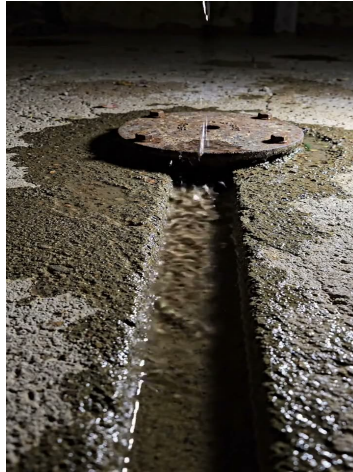
### 03 Floor, water and drainage

Water stands on part of the cellar floor near a drainage channel.

Find out whether the drain or pump is working and report standing water.

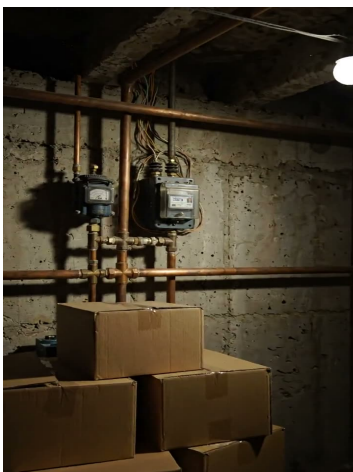
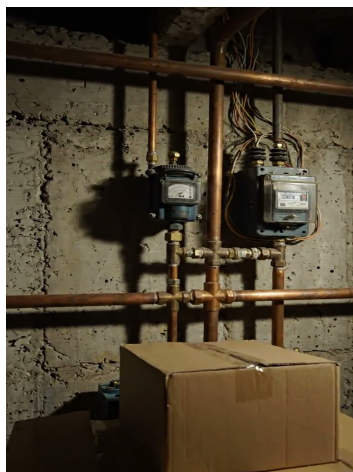
### 04 Services and storage

A gas meter and pipes are fixed to the wall above stored boxes.

Move stored items away from water and keep meters accessible.
