# Decking inspection visual route

DEMO-DECKING-CONDITION-001

Illustrative house garden / four separate scenes

Illustrative annual deck check

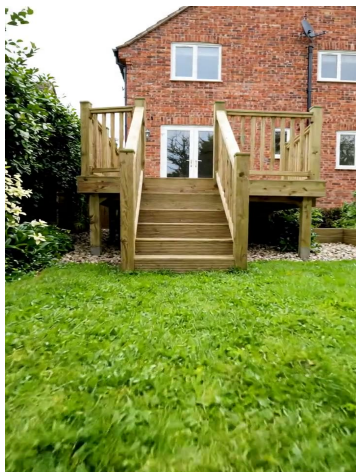
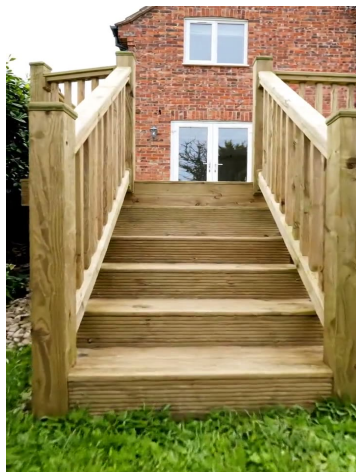
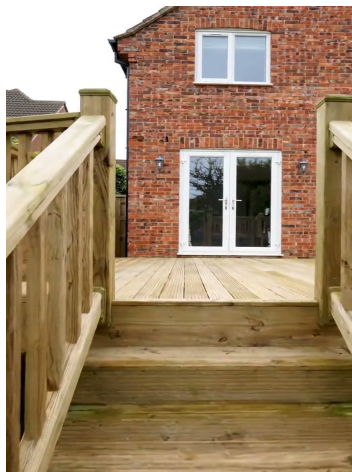
### 01 Whole deck and access

A raised timber garden deck with steps and a balustrade is shown from the lawn.

Note the deck height above ground and who uses it.

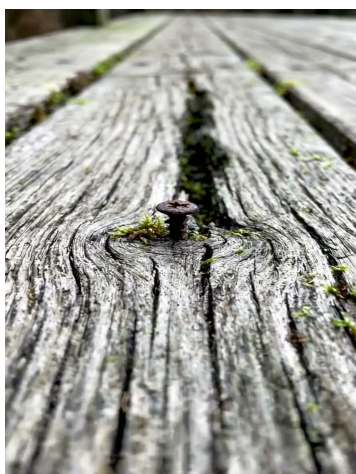
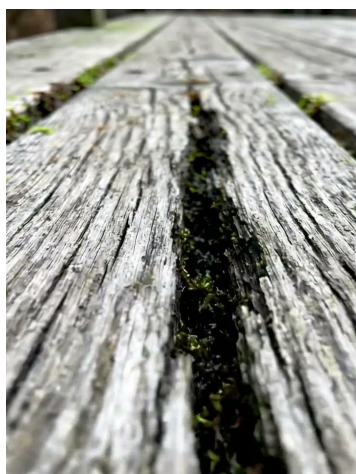
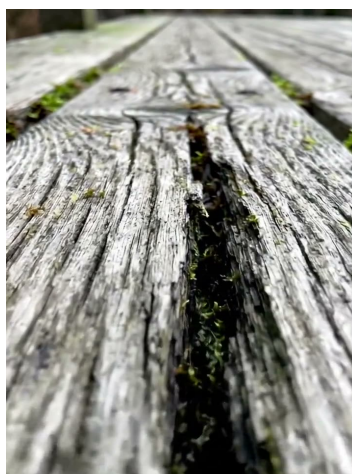
### 02 Boards and fixings

A split and darkened deck board with a raised screw head is visible.

Replace the split board and refix any raised screws.

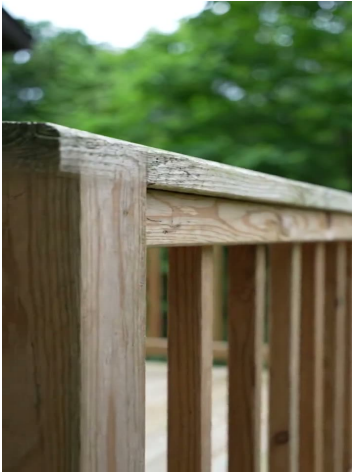
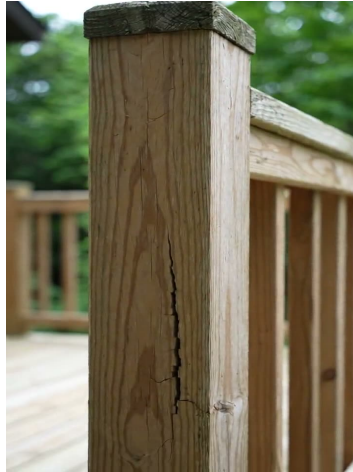
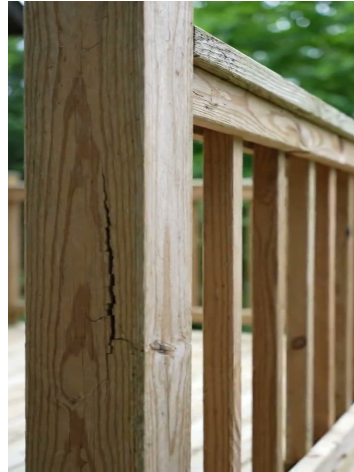
### 03 Balustrade and handrail

A timber balustrade post shows a crack near its base.

Have the cracked post checked before the deck is used.

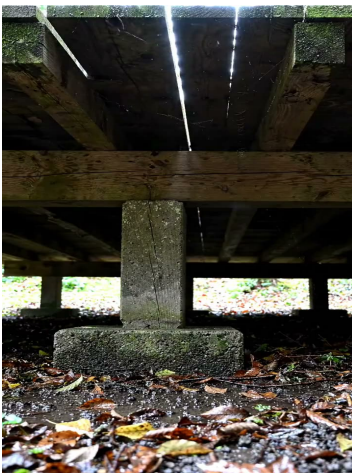
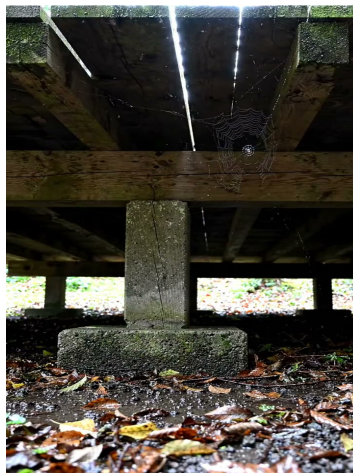
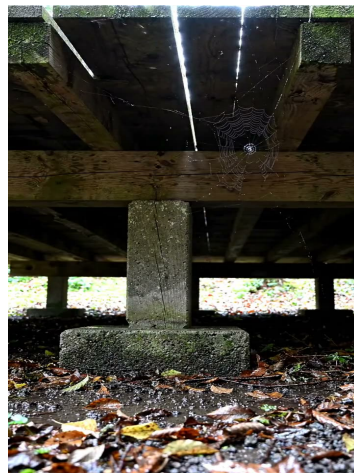
### 04 Underside and supports

Timber joists and posts are visible under the deck, with damp ground beneath.

Look for soft or rotten joists and posts at the next hands-on check.
