# Manhole inspection visual route

DEMO-MANHOLE-CONDITION-001

Illustrative business park car park / four separate scenes

17 October 2026

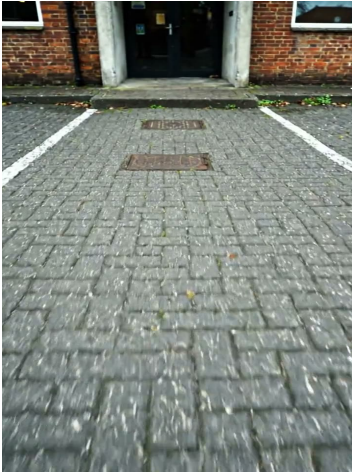
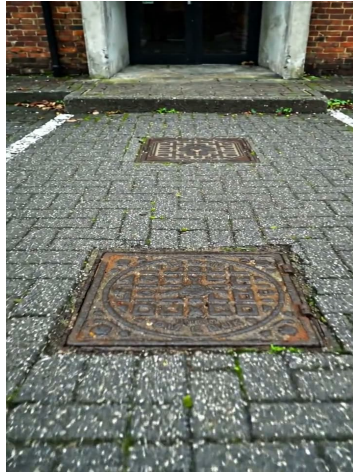
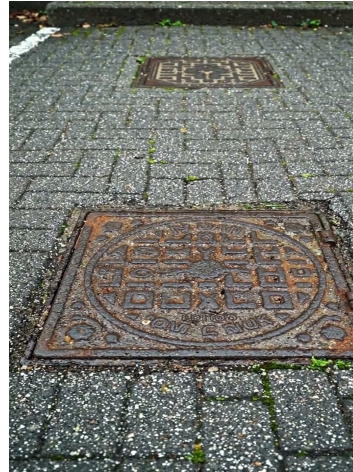
### 01 Cover location

A manhole cover is shown in a block-paved car park near a building entrance.

Note the cover reference and whether vehicles cross it.

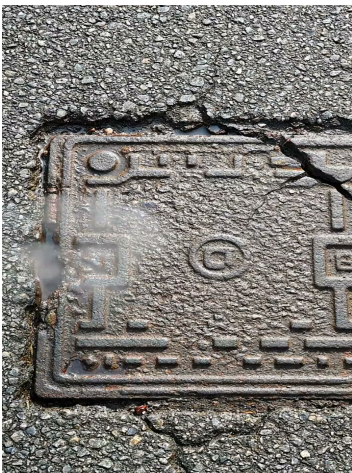
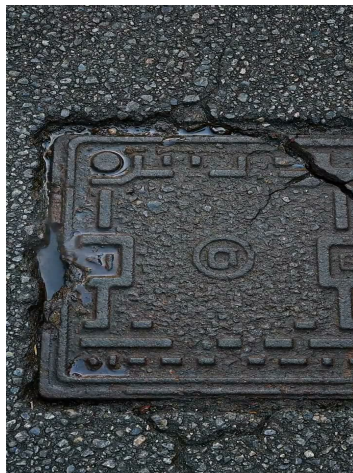
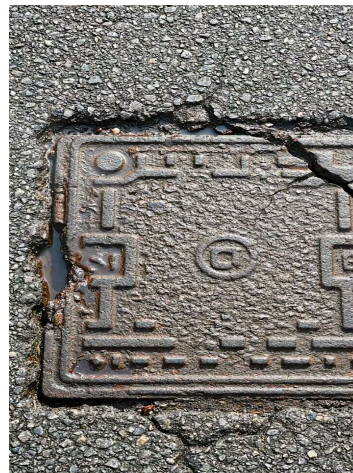
### 02 Cover condition

The cast iron cover has a cracked corner and a visible gap at one edge.

Cone off the cracked cover and book a replacement.

Cone off the cracked cover and ask a drainage contractor to replace it and check the chamber.

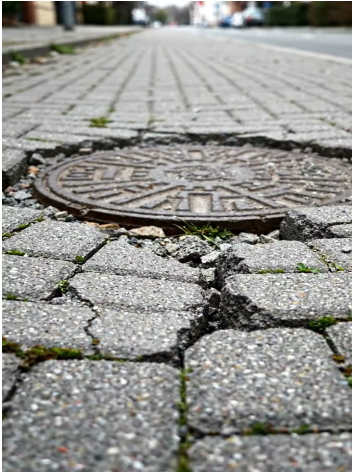
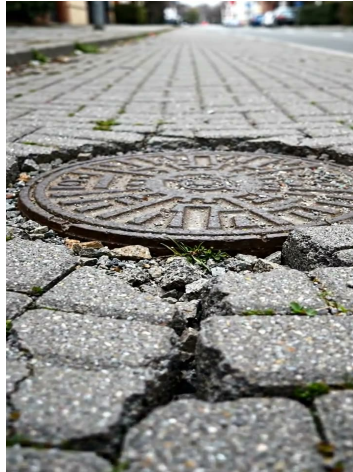
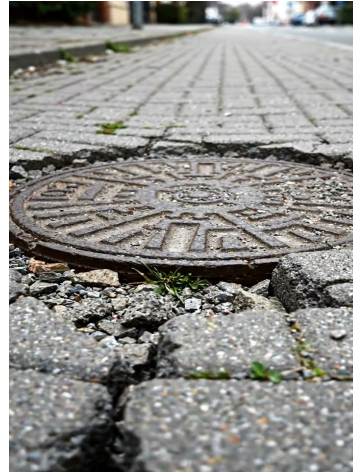
### 03 Frame and surround

Block paving around the frame has sunk and cracked.

Ask a contractor to reset the frame and repair the paving.

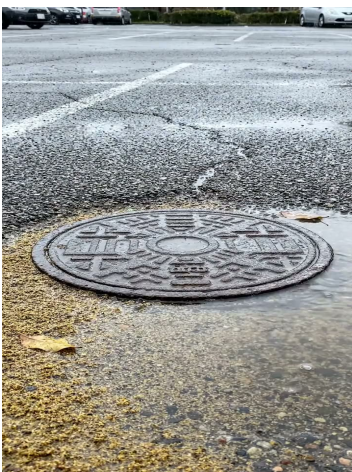
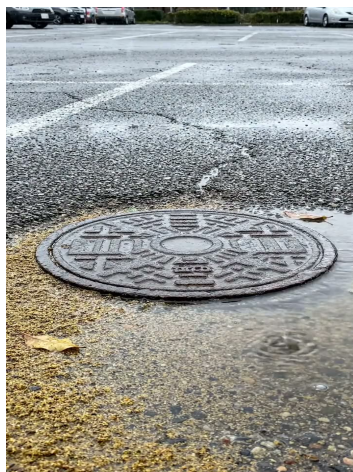
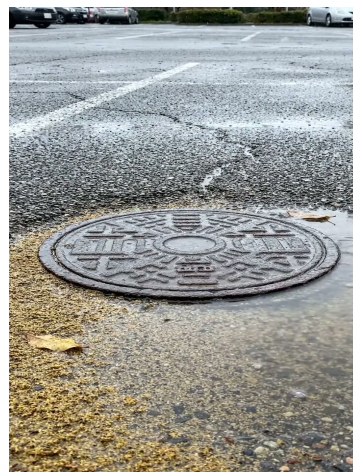
### 04 Signs of blockage or flooding

Silt and water staining surround the cover after rain.

Report standing water or sewage to the drain owner.
