# Retaining wall inspection visual route

DEMO-RETAINING-WALL-001

Illustrative footpath and raised garden / four separate scenes

FICTIONAL SAMPLE

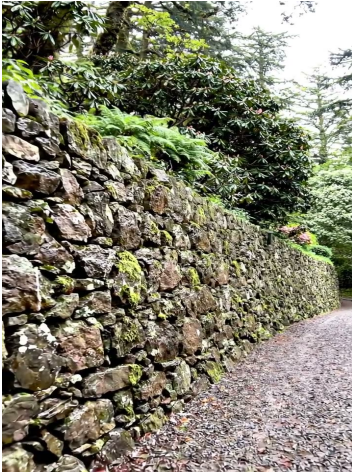
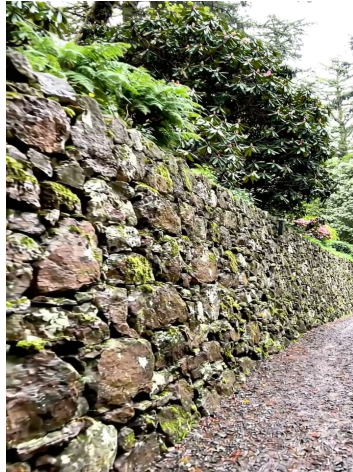
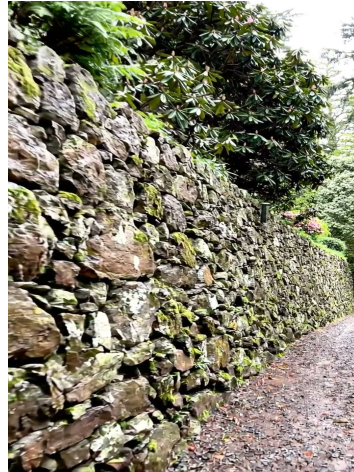
### 01 Wall length and height

A stone retaining wall holds back a raised garden beside a path.

Record the wall height and what is above it on the plan.

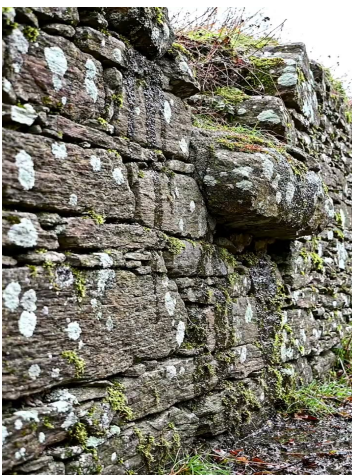
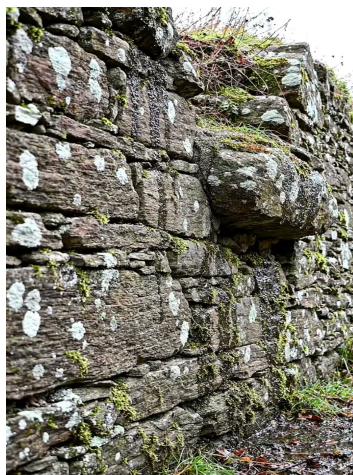
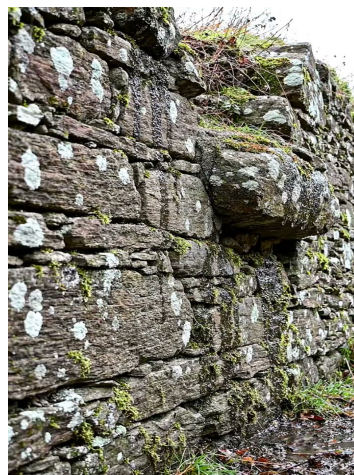
### 02 Bulging or leaning

Part of the wall face bulges outwards over a short length.

Keep people away from below the bulge and refer it to a structural engineer.

Fence off the area below the bulge if people use the path, and ask a structural engineer to assess the wall.

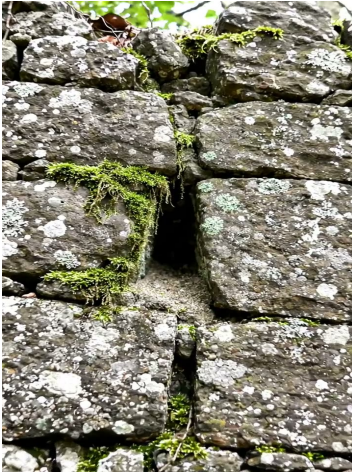
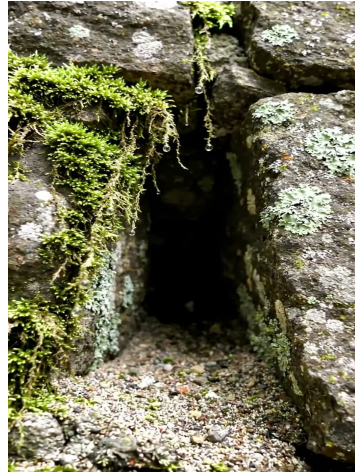
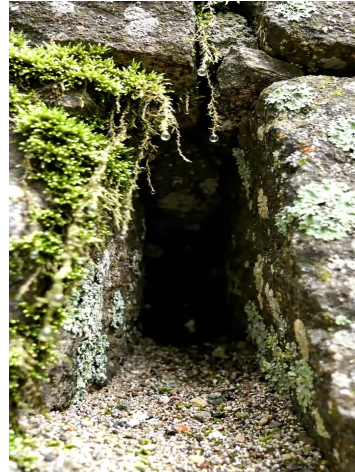
### 03 Cracks and missing stones

A vertical crack and open mortar joints are visible in the wall.

Mark the crack and missing stone so movement can be compared later.

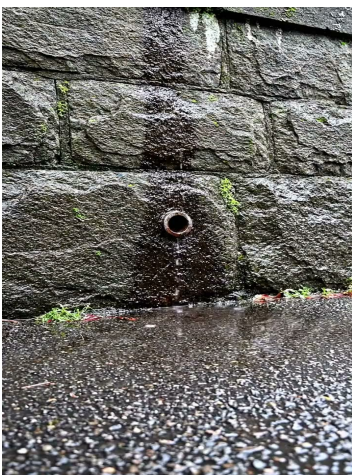
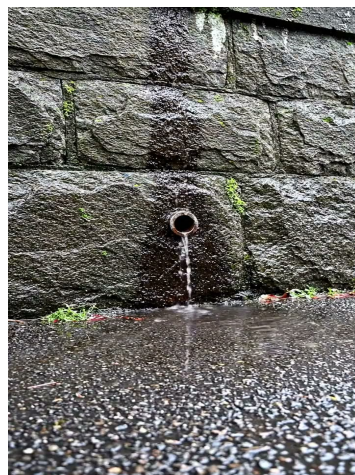
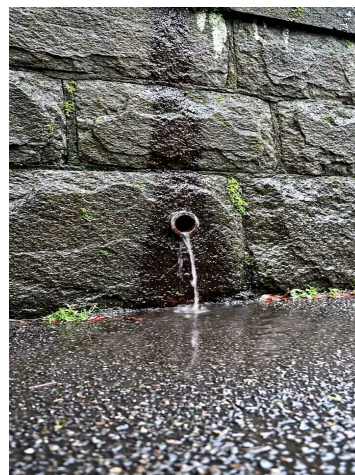
### 04 Drainage and water

Water staining runs down from the wall face to a wet path.

Clear blocked drain holes where it is safe and note water after rain.
