# Decking Inspection

| Date | 2 Oct 2026 |
| Site | 5 Orchard Rise, Shrewsbury |
| Prepared by | K. Mills |

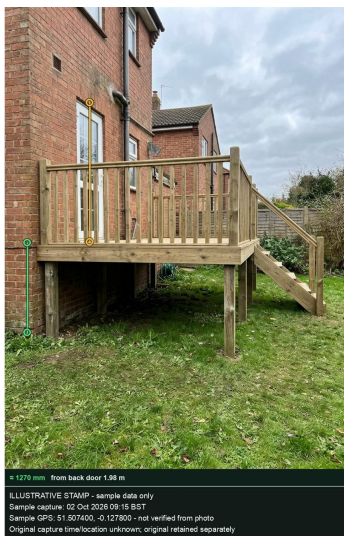
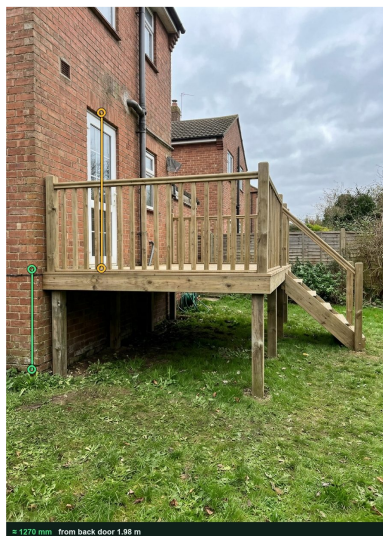
| <b>What is wrong?</b> | Third board from the house split along its length and soft at one end |
| <b>What is wrong?</b> | Corner post cracked near its base and moves when pushed |

**Defects 1: Cracked balustrade corner post, loose**

| Defect | Split and soft deck board |

**Further actions 1: Replace the corner balustrade post and refix the rails.**

**Further actions 2: Replace the split board and reset the raised screws.**
