## SITE SURVEY REPORT

# Retaining Wall Inspection

| Date | 6 Oct 2026 |
| Site | Moorside Road, Keighley |

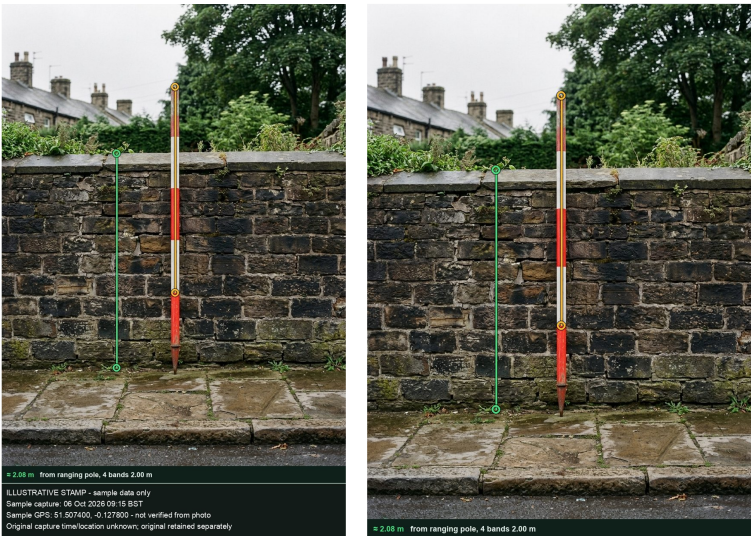
Photos of the wall

| Wall position (GPS) | Bulge, 7 m from the west end · 53.864120, -1.915870 (SE 05630 40881, ±6 m) |

| What is wrong? | Vertical crack and open joints near the bulge |
| What is wrong? | One face stone missing at the crack |
| What is wrong? | Wet staining below the bulge after rain |

| Size, in words | One face stone missing, void behind |

| What needs doing? | Structural engineer to inspect the bulge and advise on repair. |

| What needs doing? | Keep the barrier on the footway edge below the missing stone until the engineer has visited. |
