## SITE SURVEY REPORT

# Flat Roof Condition Visual Inspection

| Site | Example commercial building / roof area R-01 |

| Report reference | DEMO-ROOF-001 |

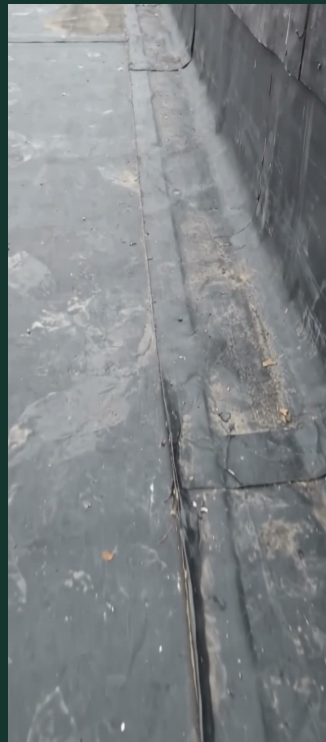
1. A raised-looking edge is visible at one membrane detail; its condition needs hands-on assessment.  
Illustrative observation - verify against the real site before use.

| Follow-up action | Refer the visible details to a competent roofing contractor under a planned safe access method; document their assessment and any repair separately. |

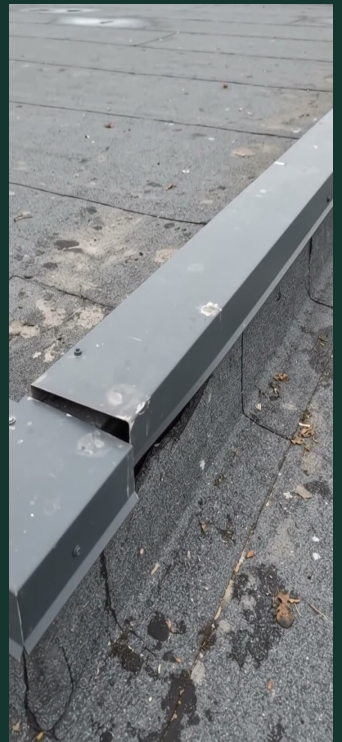
1. The parapet and one loose-looking trim section are visible from the protected area.  
Illustrative observation - verify against the real site before use.
