## SITE SURVEY REPORT

# CCTV Maintenance Visit

| Project | St Anne's Court, Lincoln: CCTV maintenance |
| Job or contract reference | CCTV-PPM-2026-044 |

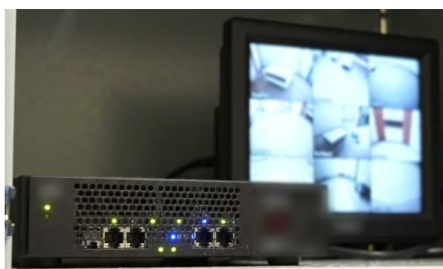
#### Cameras checked 1: CAM-01

| Location | Main entrance |
| Picture | Clear |
| Night picture | Good |
| Any defect on this camera? | No |

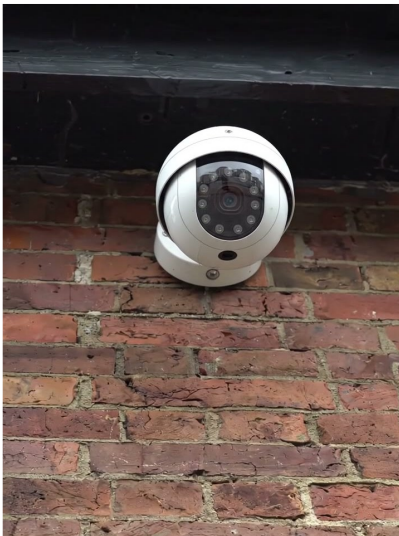
**Cameras checked 2: CAM-02**

| Location | Rear car park, building corner |
| Picture | Dirty or obstructed |
| Night picture | Poor |
| Describe the defect and what you did | Dome cover scratched. Cleaned it, but the infrared still flares at night. Replace the dome cover. |
| Priority | Soon: within a month |

| What needs doing next, and who will do it? | Replace the CAM-02 dome cover and the recorder hard disk on one visit. M. Rahman to quote both to the estates team by 7 October 2026. |
