# Chimney Sweep and Inspection Record

| Project | Ivy Cottage: stove sweep and inspection (completed example) |
| Appliance | Wood burning stove |
| Flue | Masonry with liner |

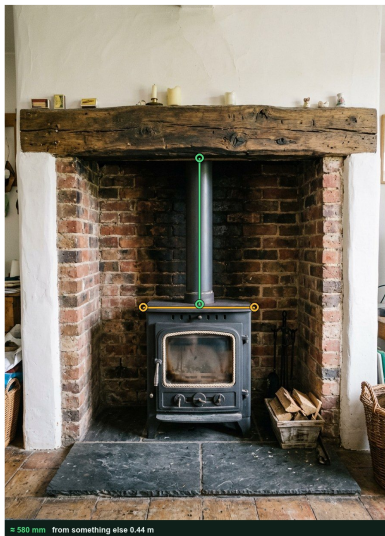
**Measured clearance to the nearest combustible (mm): measuring photo**

| Hearth and clearances to combustibles | Defect |
| What is wrong? | Stove top to the underside of the oak beam about 580 mm, less than the 750 mm in the stove's installation instructions. Advised a non-combustible heat shield or a check by the installer. |
| Measured clearance to the nearest combustible (mm) | 580 |

| Clearance the manufacturer's instructions give (mm) | 750 |
| Clearance check | Less than the instructions |

Burn seasoned wood with a moisture content of 20% or less. Second sweep due after the heating season. Stove top is closer to the oak beam than the stove instructions allow: the installer to check it and fit a heat shield or move the stove as the instructions require.
