# Clerk of Works Report

| Project | Brindley Close, Fenton, Stoke-on-Trent: 24 council homes, clerk of works week 18 (completed example) |
| Report number | CoW 18 |

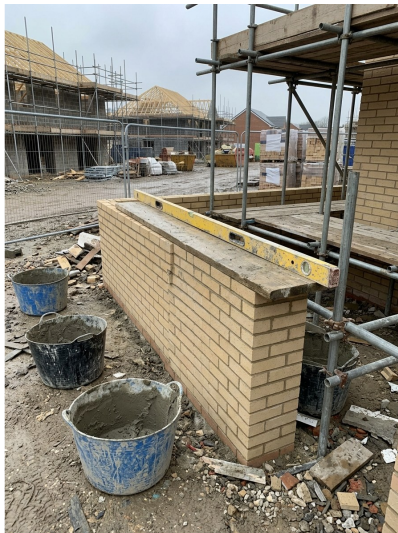
##### Progress photos

| Area | Block A, plots 1 to 6 |
| Work this week | Facing brickwork and blockwork to first floor |
| Actual complete (%) | 62 |
| Difference from the programme (percentage points) | -8 |
| Why it is behind, as the contractor explains it | Contractor puts it down to the rain on 13 and 14 Oct; extra bricklayers on site from 19 Oct to recover it. |

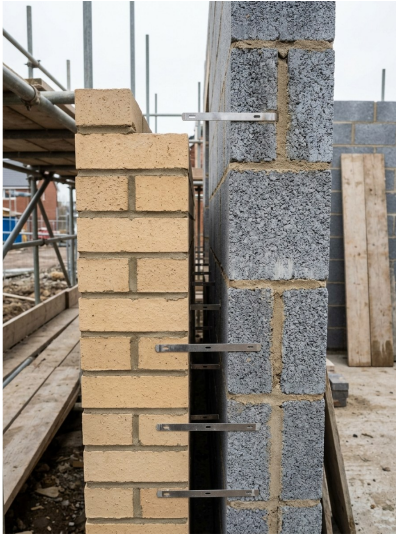
## Photo

| Ref | Q18-01 |
| Location | Plot 4 rear elevation |
| Element | Cavity wall ties |

| What you saw | Ties built in at the spacing on the drawing, bedded in both leaves, drips pointing down, cavity clear of mortar at this lift. |
| Defect or not | Good workmanship noted |

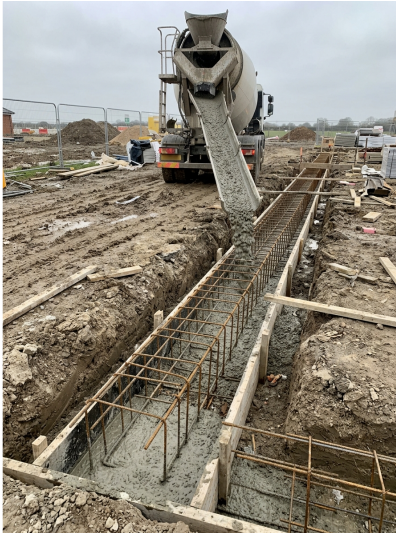
**Progress photos**

| Area | Block B, plots 7 to 12 |

| Work this week | Ground beam reinforcement and pour |

| Actual complete (%) | 40 |

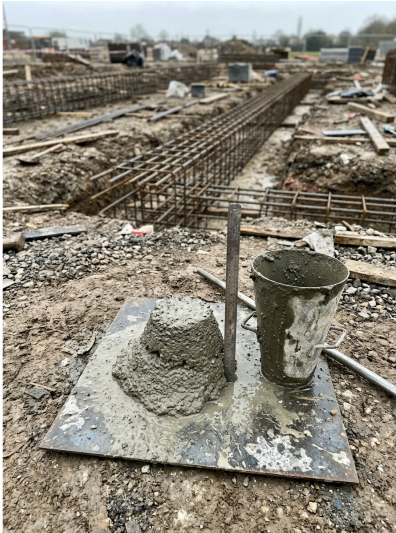
Photo

| Sample or test | Concrete slump test |

| Where | Block B ground beams, second truck |

| Result | Passed |

| Reading or result as recorded | 80 mm, within the range on the mix order |

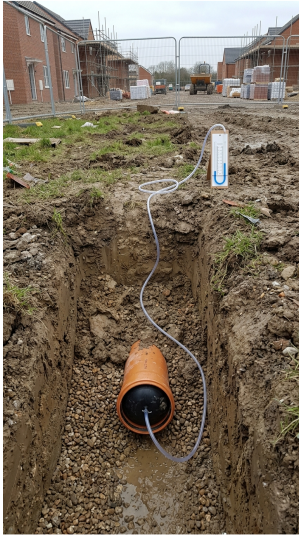
## Photo

| Sample or test | Foul drain air test |
| Where | Plots 1 to 6, run MH1 to MH3 |
| Result | Passed |
| Reading or result as recorded | Held for the time in the specification, no drop on the manometer |

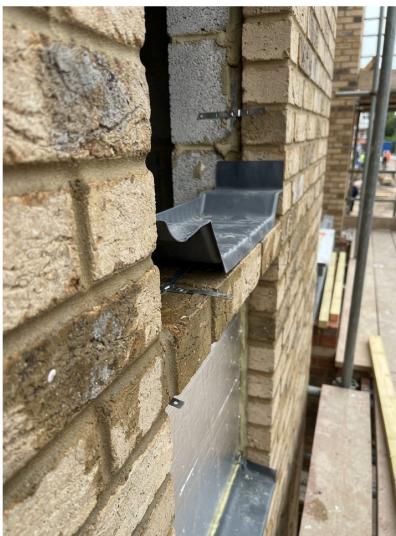
#### Photo

| Ref | Q17-01 |
| Location | Plot 3, window W2 |
| Defect | Wall ties missing at the window reveal. |

| Status this week | Put right and checked |
| What showed it was put right | Ties seen built in at the reveal before the next lift, 13 Oct. |
