# Cold Water Storage Tank Inspection

| Project | Harbour View Offices, Plymouth: cold water storage tank inspection (completed example) |

| Tank ID, service and location | CWST-01, mains-fed sectional GRP tank serving the building's cold water, roof plant room |

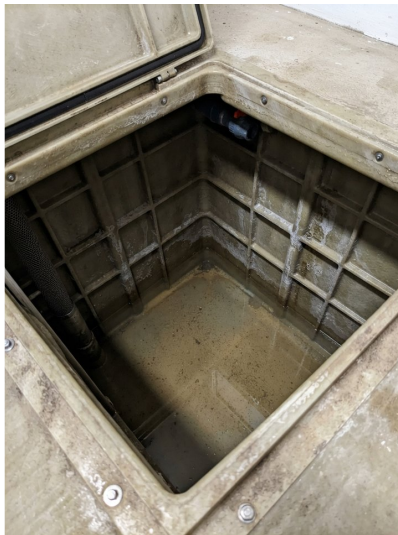
##### Condition photographs

| Action, limitation or reason not applicable | Water clear. Light brown sediment over most of the base visible through the hatch. Referred for clean and disinfection by the water contractor. |

**Further action 2: Clean and disinfect CWST-01 to remove base sediment. Job HV-2609-119.**

| Action and evidence reference | Clean and disinfect CWST-01 to remove base sediment. Job HV-2609-119. |

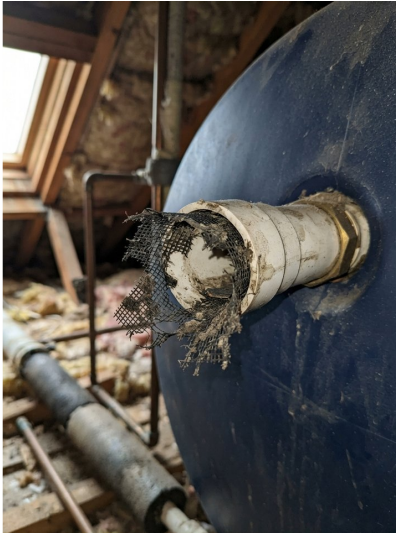
## Condition and defect evidence

| Action, limitation or reason not applicable | Lid sound and bolted down. Insect screen on the overflow is torn at the bottom edge, about 40 mm gap. Vent screen intact. |

**Further action 1: Replace the torn insect screen on the overflow. Job HV-2609-118.**

| Action and evidence reference | Replace the torn insect screen on the overflow. Job HV-2609-118. |
| Completion evidence | New stainless mesh screen fitted 2026-10-01. Photo on job HV-2609-118. |
