# Commercial Catering Gas Check

| Site | The Blue Anchor kitchen |

| Project | The Blue Anchor kitchen: annual gas safety check (completed example) |

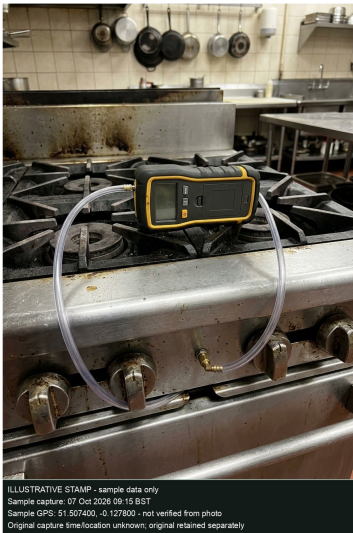
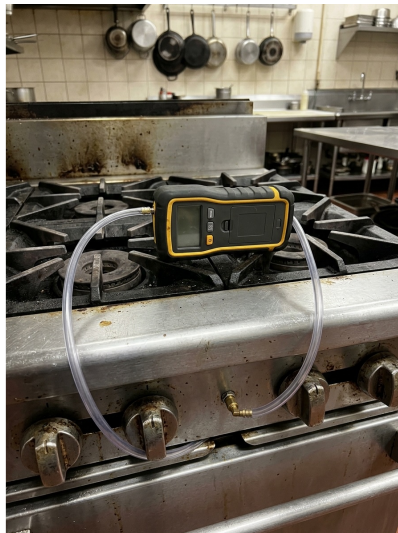
Appliance (for example 6-burner range, fryer, combi oven) 6-burner range with oven

Flame supervision devices work OK

Flue or extract canopy OK

Combustion and burner pressure OK

Burner pressure measured (mbar) 10.2

Burner pressure on the data plate or in the instructions (mbar) 10.0

Measured minus data plate (mbar) 0.2

Result Safe

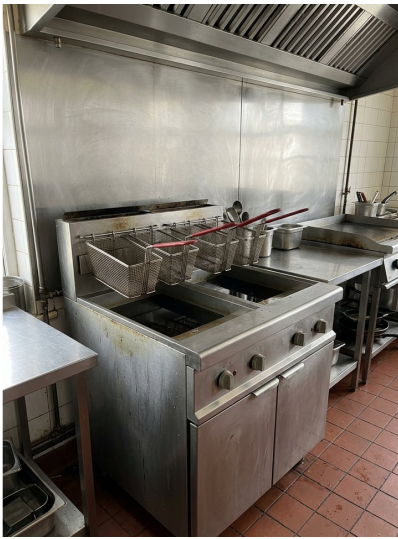
Appliance (for example 6-burner range, fryer, combi oven) Twin tank fryer

Flame supervision devices work Defect

Burner pressure measured (mbar) 12.4

| Burner pressure on the data plate or in the instructions (mbar) | 12.5 |
| Measured minus data plate (mbar) | -0.1 |
| Result | At risk |

| Action taken | Thermocouple on tank 2 slow to drop out. Turned off with the head chef's agreement and labelled DANGER DO NOT USE; part ordered. |
| Warning notice given to the responsible person and signed? | Yes |
