# Concrete Slab Inspection

| Site | Trinity Crossing Building B, Fort Worth |

| Project | Trinity Crossing Building B, Fort Worth: slab inspection (completed example) |

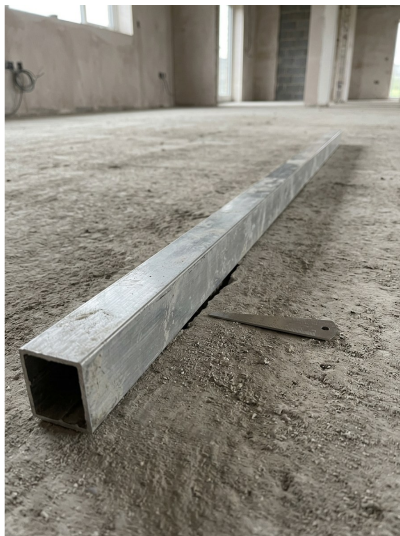
## Photos of the straightedge or the out-of-tolerance area

| Lowest local FL measured | 15 |
| Flatness against the specification | Below the specified F-numbers |
| Where it is out | Local section at F/2 in front of dock door 7, low spot about 8 ft by 6 ft; washdown water stands there |

| Action | Submit a repair method for the low spot at F/2 by dock door 7, then repair and have the flatness retested. |
