# Construction Daily Report

| Project | 3 Mill Yard, Sheffield: construction daily report (completed example) |
| Site | 3 Mill Yard, level 2 office fit-out |

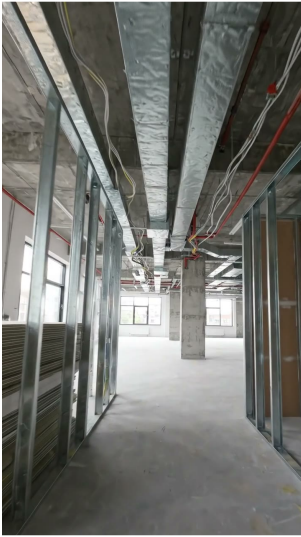
| Area or plot | Level 2, meeting rooms 1 to 6 |

| What was done today? | Metal stud partitions completed to meeting room 6. Boarding started on rooms 1 and 2. |

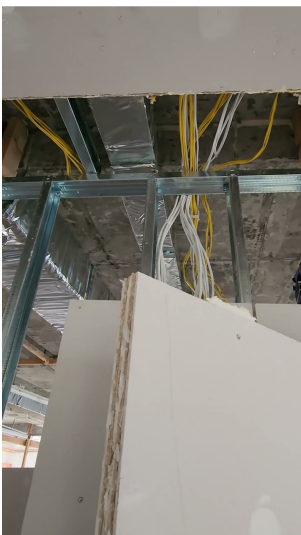
Level 2, meeting room 4

Partition head not yet sealed to the slab. Drylining to finish and fire stop before the ceiling closes.

| Work planned for tomorrow | Board meeting rooms 3 to 6. Finish the head detail in meeting room 4. Start the tray in zone C. |

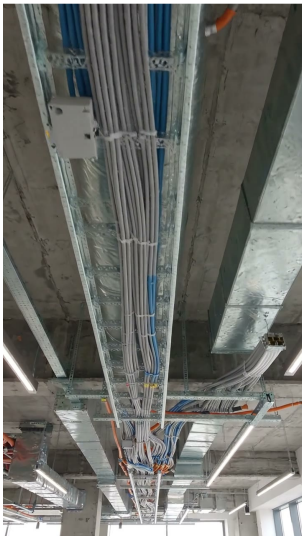
Level 2, zone B ceiling void

Cable tray complete and data cabling pulled to zone B. Zone C still to do.
