# Container Inspection

| Project | Harbour Logistics: export container check before loading (completed example) |
| Container or trailer number | HBLU 482913 9 |
| Type | 40 ft high cube |

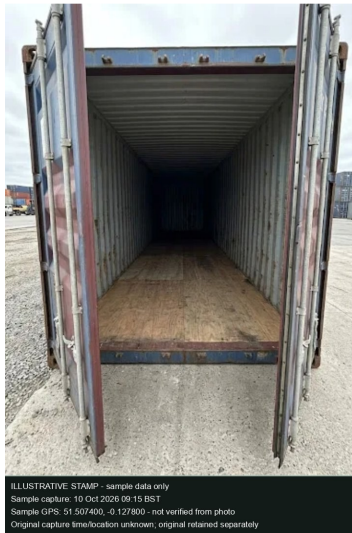
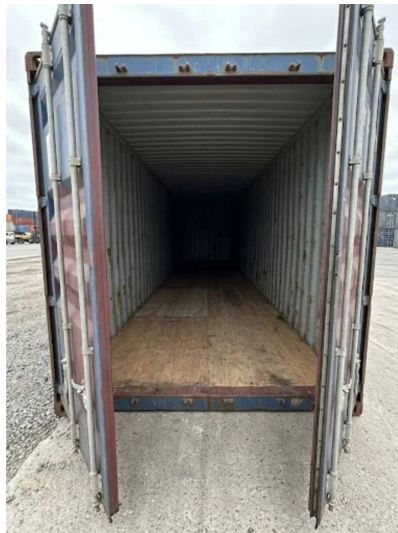
**Photos (doors, inside, any defects)**

| Floor (inside) | Defect |

Shallow gouge in the floorboards by the doors, not through; no light showing. Accepted for this load.
