# Emergency Lighting Test Record

| Site | Kingsgate Business Centre |

| Project | Kingsgate Business Centre: annual emergency lighting test (completed example) |
| Which test? | Annual full duration test |

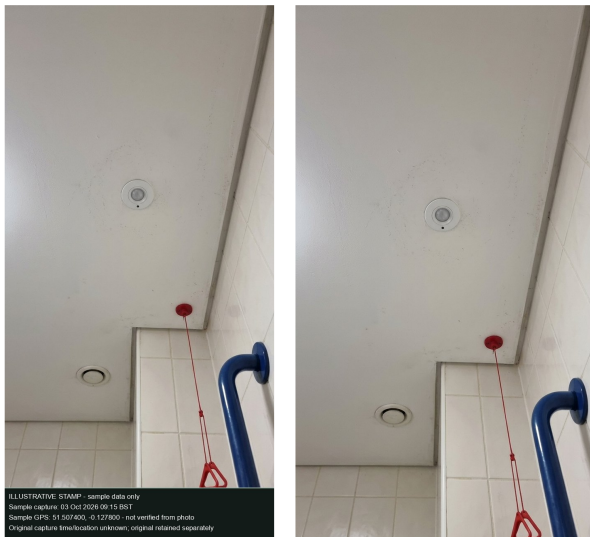
**Photos of the fault**

| Luminaire or circuit reference | EL-11 |
| Position in this area | Accessible WC |
| Type | Downlight |
| Charge indicator | Not lit |
| Result | Fail |
| What was wrong? | Did not light |

| Action taken or needed | No charge indicator and no light on test. Supply checked at the local fused spur: live. Fitting to be replaced. |

| What needs doing? | Replace the EL-11 downlight and re-test. |

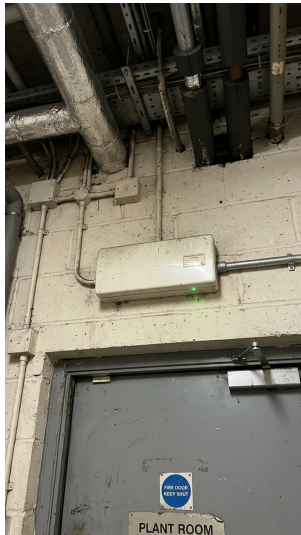
### Photos of the fault

| Luminaire or circuit reference | EL-14 |

| Position in this area | Plant room door |

| Type | Non-maintained bulkhead |

| Result | Fail |

| What was wrong? | Went out before the end of the test |

| Went out after (minutes) | 52 |

| Action taken or needed | Battery pack failed at 52 minutes. Replacement ordered; temporary torch left by the door. |

| What needs doing? | Replace the battery in EL-14 and re-test for 3 hours. |
