# Fall Protection Plan

| Site | Westbrook Elementary gym and classroom wing re-roof, Omaha, NE |

| Project | Westbrook Elementary gym and classroom wing re-roof, Omaha, NE: fall protection plan (completed example) |

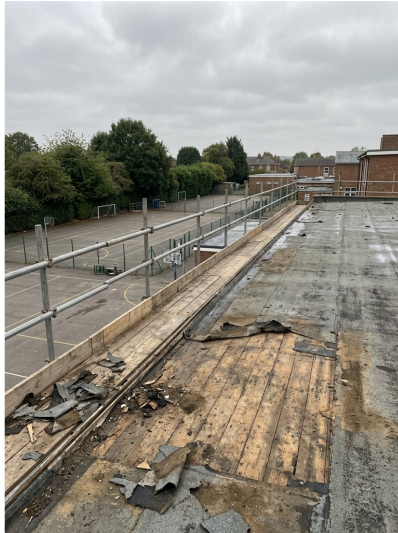
Photos of the area and its protection

| Work area | Main roof, gym |
| Location on site | West half, tear-off and new membrane |
| Height to the lower level (ft) | 24 |
| Edge or hazard | Low-slope roof edge (4 in 12 or less) |
| Fall protection chosen | Guardrail system, Warning line system |
| Why this method, and any other measures | Guardrail on the west and north edges where tear-off runs to the edge. Warning line 8 ft in on the other edges for field work. Edge work outside the line only from the guarded side. |
| Guardrail: top rail height measured (in) | 42 |
| Warning line: smallest distance from the roof edge (ft) | 8 |
| Flagged and at 34 to 39 in high? | Yes |
