# Fire Damper Test Record

| Site | Castle Court Offices |

| Project | Castle Court Offices: annual fire damper drop test (completed example) |
| Damper schedule or drawing reference | Damper schedule DS-02 rev B |

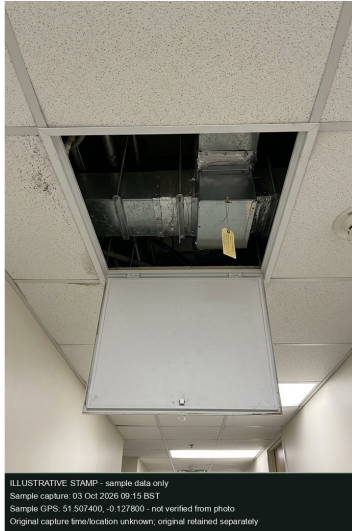
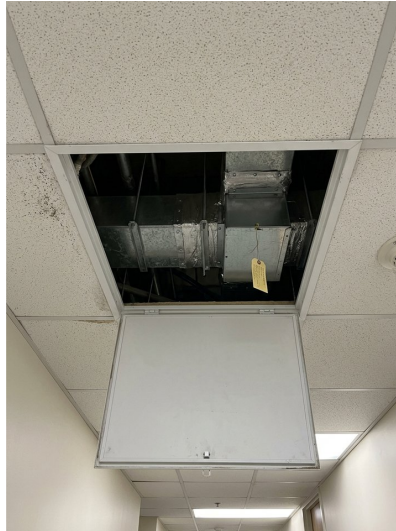
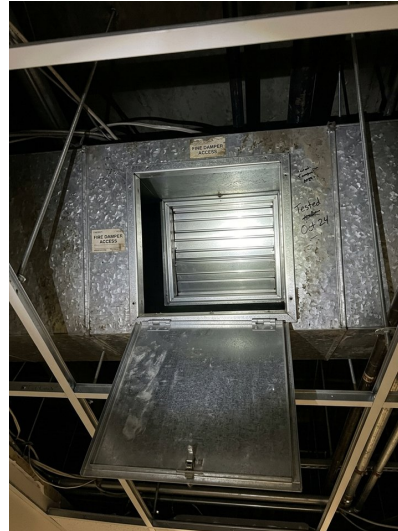
#### Photos (before and after the test)

| Damper reference | FD-01 |
| Location | Level 1 corridor ceiling |
| Type | Fusible link (spring) |
| Visual check (clean, no corrosion, no obstruction) | OK |

Drop test: closed fully Pass

Result Pass

Reset and left open? Yes

Fusible link replaced with a correctly rated link? Yes

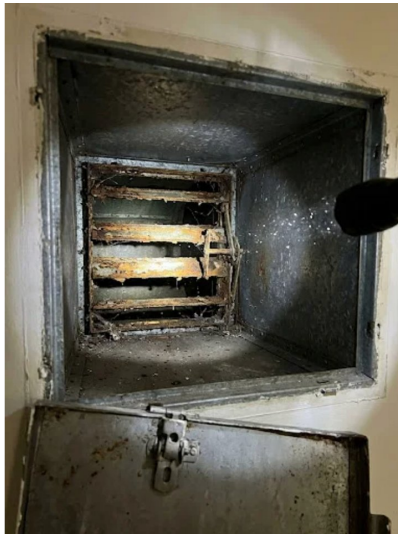
**Photos (before and after the test)**

| Damper reference | FD-02 |
| Location | Level 1 plant room wall |
| Visual check (clean, no corrosion, no obstruction) | Defect |
| Drop test: closed fully | Fail |
| Result | Fail |
| Fault and action | Blade seized by corrosion; did not close, so not reset and link not replaced. Quoted for replacement. |

A failed damper may not close in a fire. Arrange repair or replacement and tell the responsible person.

| Who will arrange the remedial work, and by when? | L. Price to approve the FD-02 quote and arrange an access panel for FD-03 by 31 Oct 2026. |
