# Fuel Tank Visual Inspection

| Project | Fenland Cold Store, Wisbech: generator diesel tank check (completed example) |

| Tank ID, location and owner | FT-01, above-ground steel tank beside the standby generator, rear yard. Owned by Fenland Fresh Ltd. |

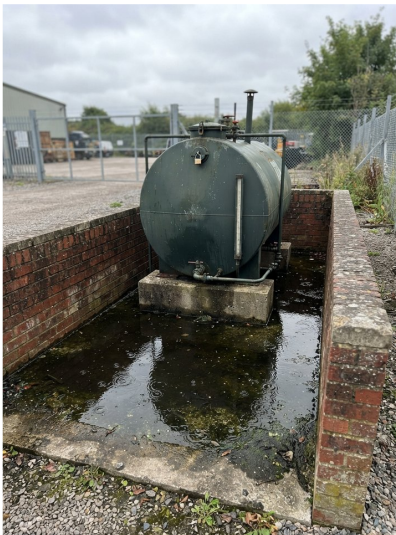
### Tank and findings photos

| Tank shell, supports and visible damage checked | Acceptable |
| Action, limitation or reason not applicable | About 40 mm of rainwater in the bund. No sheen or oily smell seen. Bund walls sound. Drain valve closed and padlocked. |

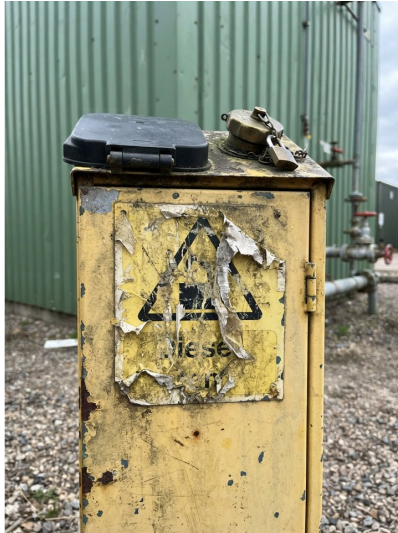
## Condition and defect evidence

| Action, limitation or reason not applicable | Fill point cabinet locked. Product label on the fill point faded and part missing. Overfill alarm not tested, outside the scope of this check. |

| Water, oil or debris in containment and authorised disposal action | About 40 mm of rainwater, no oil seen. Water to be removed by a licensed waste contractor rather than drained to the surface water drain. |

**Further action 1: Arrange removal of rainwater from the bund by a licensed waste contractor and keep the waste paperwork.**

**Further action 2: Fit a new product label (diesel) at the fill point.**

**Further action 3: Book the overfill alarm test with the generator service contractor.**
