# Gas Boiler Service Record

| Site | Wellgate Library, Rotherham |

| Project | Wellgate Library, Rotherham: annual gas boiler service, boiler B2 (completed example) |

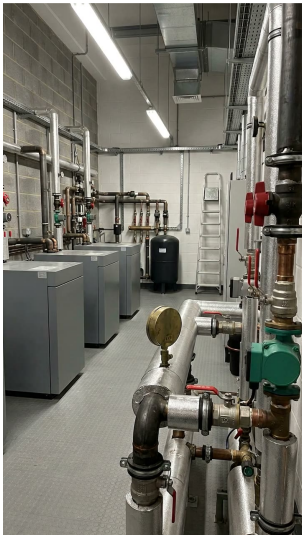
Condition and defect evidence

| Action, limitation or reason not applicable | Condensate trap part blocked with sludge, likely cause of the lockout. Trap cleaned and refilled. External condensate run in the light well is not insulated. |

| Cleaning, parts and adjustments performed | Burner and electrodes cleaned, heat exchanger inspected and cleared of debris, condensate trap cleaned and refilled, ignition electrode gap set to instructions. Seals checked on reassembly. No parts fitted. |

**Further action 1: Insulate the external condensate pipe in the light well before winter to reduce the risk of freezing. Quote DVH-Q-0912.**
