# Gemba Walk Checklist

| Prepared for | Unit 4, Calder Park, Wakefield (fictional) |
| Date | 1 Oct 2026 |

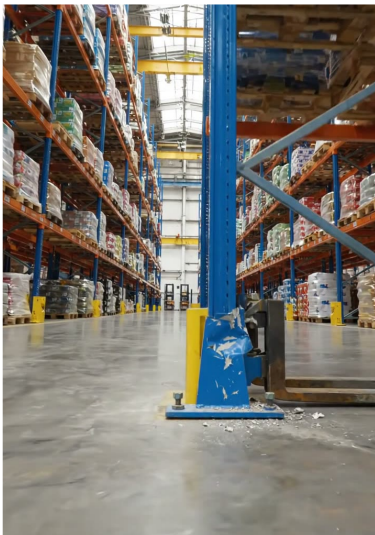
| What did you see? | Front upright at aisle 8, bay 11 dented near the floor. Bay was loaded. Second upright strike in these aisles this week (aisle 7, bay 3 found at the safety audit on 29 September). |

| Action | Racking inspection and replacement upright, bay stays tagged out until then. Review truck routes in aisles 7 and 8 with the safety adviser. |

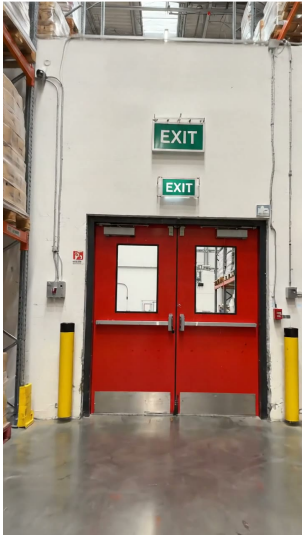
| What did you see? | Fire exit at the end of aisle 7 clear, signed and the floor marking kept free of pallets. |
