# Gym Equipment Inspection

| Project | Castlegate Leisure Centre, Shrewsbury: monthly gym equipment check (completed example) |

| Equipment ID, type and location | GYM-014, dual cable crossover station, free weights area, first floor gym |

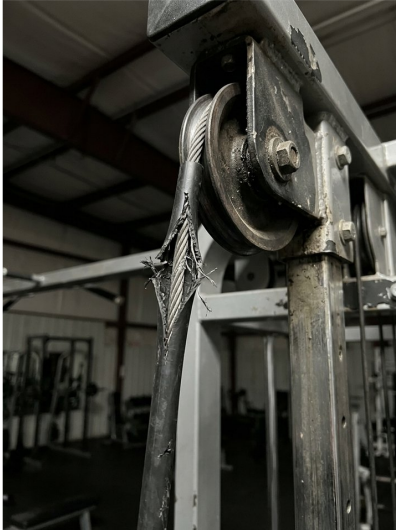
**Defect evidence**

| Action, limitation or reason not applicable | Left cable sheath frayed for about 60 mm where it runs over the top pulley. Steel strands visible. Right cable sound. |

| Restrictions, isolation and person informed | Whole station taken out of use: left handle removed and stored at reception, weight pins removed and out of order sign fitted. Gym supervisor R. Jones told at 10:20. |

**Further action 1: Contractor to replace the left cable and check the top pulley. Call-out FS-CO-26-0193.**
