# HHSRS Hazard Assessment

| <b>Project</b> | 9 Mill Lane: HHSRS assessment (completed example) |
| <b>Site address</b> | 9 Mill Lane, Rochdale |
| <b>Inspection date</b> | 5 Oct 2026 |

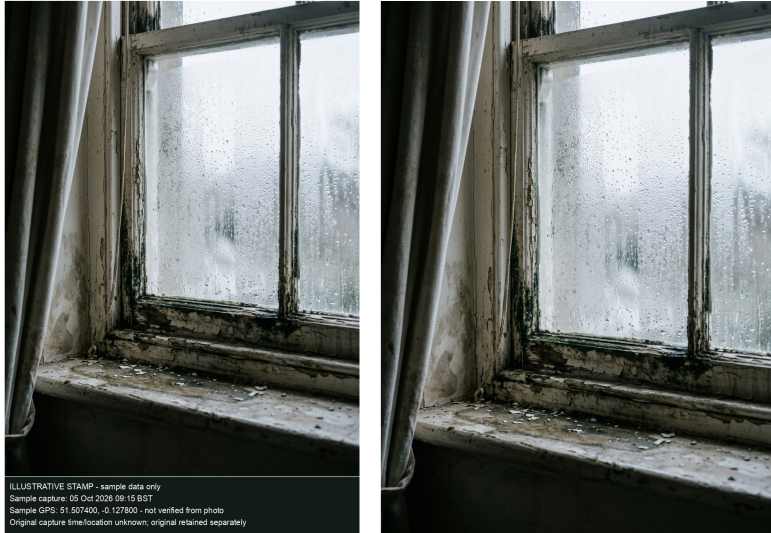
| <b>Hazard</b> | Excess cold |
| <b>Deficiencies found</b> | No fixed heating; single glazed sash windows; no loft insulation. |

| Reasons for the likelihood and spread of harm | National average for a 1920 to 1945 house is 1 in 500. No fixed heating, single glazing and no loft insulation make harm to someone aged 65 or over much more likely, so 1 in 10. Spread of harm left at the national average. |
| Hazard score | 31145 |
| Risk band | High (Category 1) |

| Works to remove or reduce the hazard | Install a fixed heating system and insulate the loft. |

| What needs doing? | Serve an improvement notice for the Category 1 excess cold hazard. |

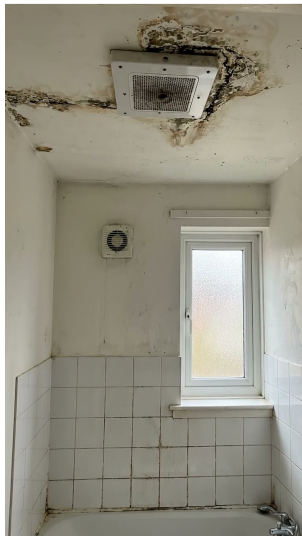
| Hazard | Damp and mould growth |
| Deficiencies found | Mould on the bathroom ceiling; no working extractor. |

| Reasons for the likelihood and spread of harm | National average for a 1920 to 1945 house is 1 in 300. Mould on the bathroom ceiling with no working extractor makes harm to a child aged 14 or under more likely, but the room is used for short periods, so 1 in 30. Spread of harm left at the national average. |
| Hazard score | 163 |
| Risk band | Medium |

| Works to remove or reduce the hazard | Fit a humidistat extractor fan and treat the mould. |

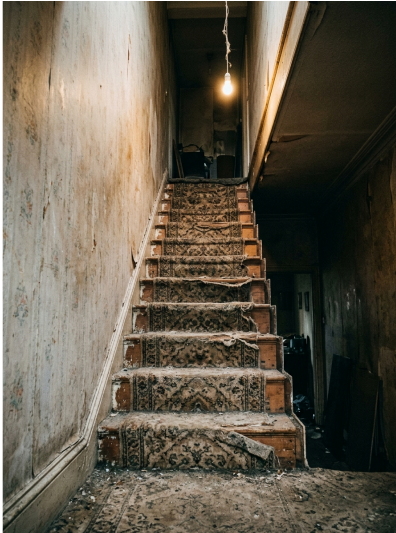
| Hazard | Falling on stairs etc. |
| Deficiencies found | Steep, narrow stair with no handrail on the open side of the lower flight; worn carpet on the nosings. |

| Reasons for the likelihood and spread of harm | National average for a 1920 to 1945 house is 1 in 200. No handrail on the lower flight makes a fall more likely for someone aged 60 or over, so 1 in 100. Spread of harm at the national average. |
| Hazard score | 317 |
| Risk band | Medium |

| Works to remove or reduce the hazard | Fit a continuous handrail. |

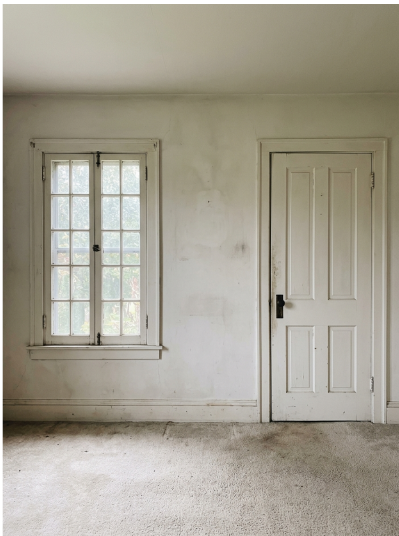
| Hazard | Falling between levels |
| Deficiencies found | Bedroom 2 (first floor, front) has a casement window with a low sill and no restrictor. The child's bed is under it. |

| Reasons for the likelihood and spread of harm | Sill measured at about 0.56 m above the floor, low enough for a young child to climb on to from the bed. The window opens fully with no restrictor, over a paved yard about 3 m below. Judged against the Part 2 profile for the age of the house, for a child aged under 5: 1 in 300, with a spread weighted to serious and moderate harm. |

| Hazard score | 72 |

| Risk band | Low |

| Works to remove or reduce the hazard | Fit restrictors to the bedroom 2 window and move the bed away from it. |

| What needs doing? | Ask the landlord to fit restrictors to the bedroom 2 window now; informal letter sent the same day. |

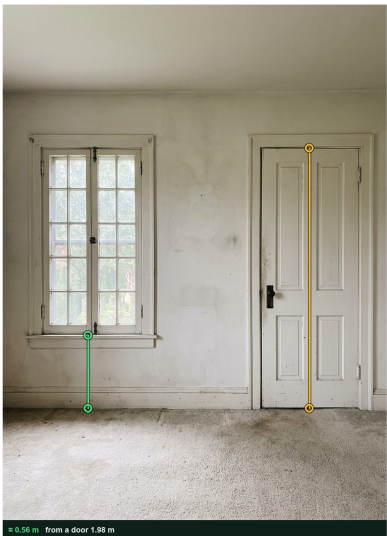
Measurement (m): measuring photo

| What was measured, if anything | Bedroom 2 window sill height above the floor |
| Measurement (m) | 0.56 |
