## SITE SURVEY REPORT

# Home Renovation Checklist

| Project | 14 Larkspur Terrace, Leicester: home renovation (completed example) |

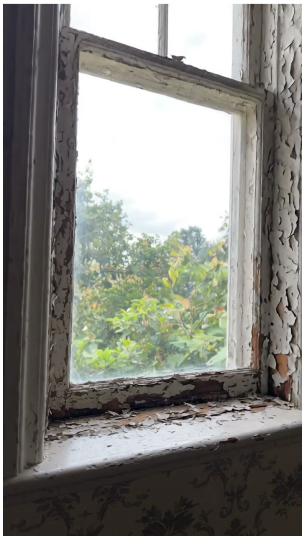
Existing condition photos (before work)

| Existing damage or defects noted before work | Paint flaking badly on the sash frame and window board. Old patterned paper on the walls. |

| <b>Work in this room</b> | Strip the old wallpaper, make good the plaster, paint walls and ceiling. Ease the sash window, prepare and repaint the frame and window board. |

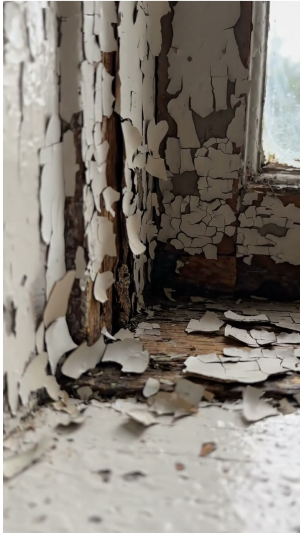
## Hazard photos

| What was found, where, and what will be done | Old flaking paint on the rear bedroom sash and window board. Treated as possibly containing lead: no dry sanding or heat, wet scrape, floor sheeted, debris bagged daily. |
