# Hot Tub and Spa Pool Check

| Site | Heron Lakes Lodges, Lodge 7 |

| Hot tub or spa pool (unit or location) | Lodge 7 deck hot tub (HT-07) |

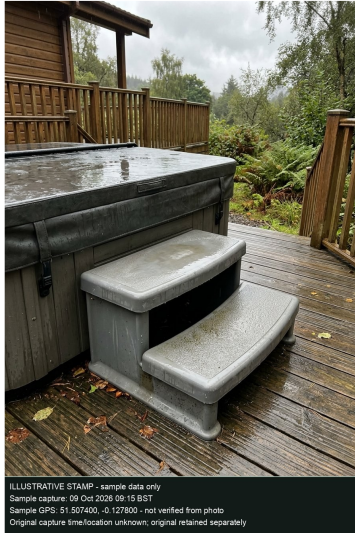
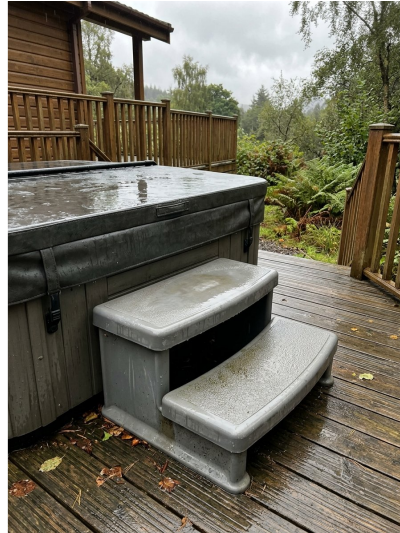
## Photos of defects

| Dosing system working | Defect |

| Steps and surround: no damage or slip hazard | Defect |
| What is wrong? | Step tread worn on the top step, slip risk when wet |

**Further actions 1: Hot tub closed after the 09:15 test. Inline chlorine feeder refilled and pH adjusted; retest at 10:05 in range, so reopened. Recheck at the afternoon test**

**Further actions 2: Fit a new step tread before the next arrival**

| What needs doing? | Fit a new step tread before the next arrival |
