# Hotel Room Inspection

| Project | Abbey Gate Hotel, Bath: room 214 inspection |

| Room number and type | Room 214, superior double |

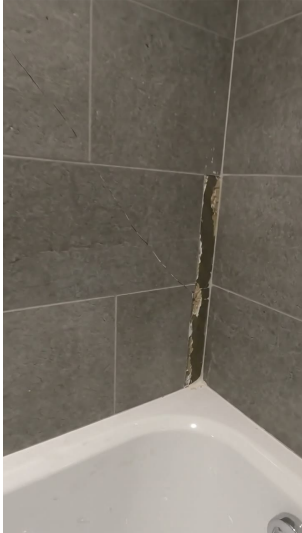
Defect evidence without guests or personal belongings

| Action, limitation or reason not applicable | Cracked wall tile and grout missing down the corner joint above the bath. No water marks seen yet. Logged for maintenance. |

| Reason and person notified | Open joint above the bath could let shower water behind the tiles. Duty manager R. Iqbal told at 11:40, arriving guest moved to room 218. |

| Reinspection reference and release decision maker | Reinspection RI-214-1004 once the grout has cured, release decided by the housekeeping manager |

**Further action 2: Replace the cracked tile and regrout the corner above the bath. MNT-26-1003-07.**
